Addendum No. 1

Your reference is directed to **Request for Proposal DRAINAGE PUMP STATION 13 ASBESTOS ABATEMENT** which is scheduled to open at **11:00 a.m. CST** on **October 16, 2020** for SWBNO

Asbestos Survey Report

Drainage Pump Station 13
4201 Tall Spruce Drive
New Orleans, Louisiana

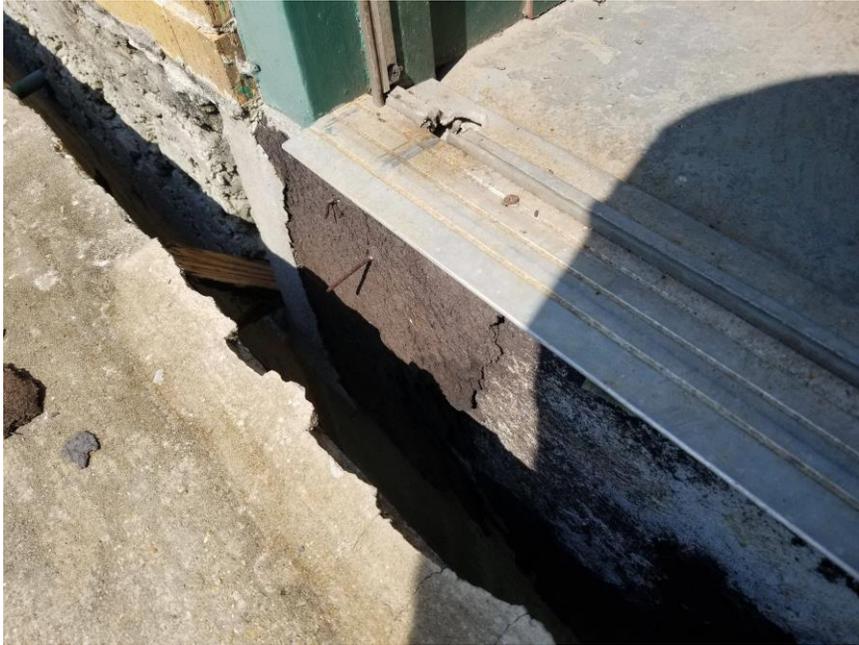
Photograph No. 1
View of HA – 01: Black waterproofing on slab.

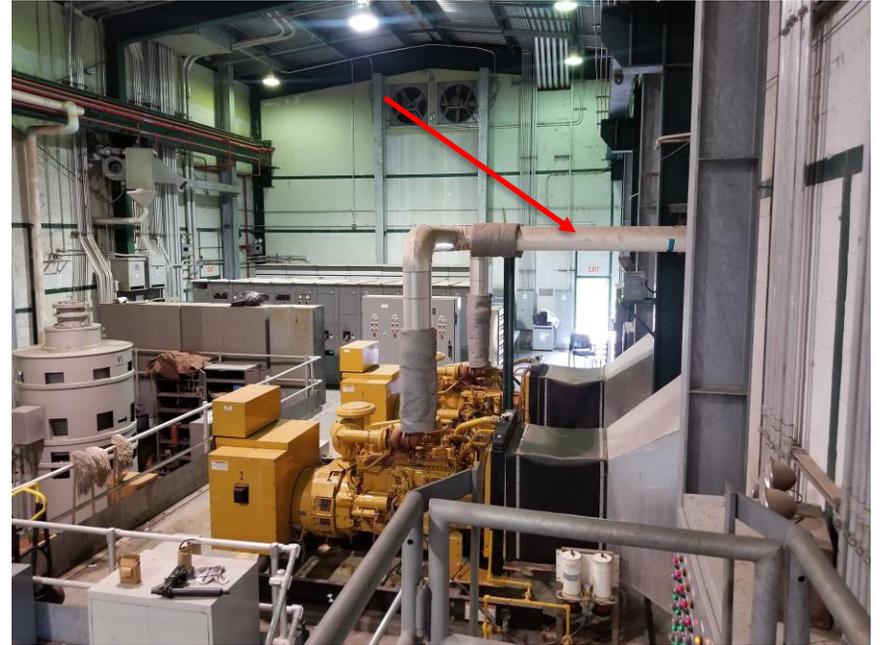
Photograph No. 2
View of HA – 02: White 10" TSI.

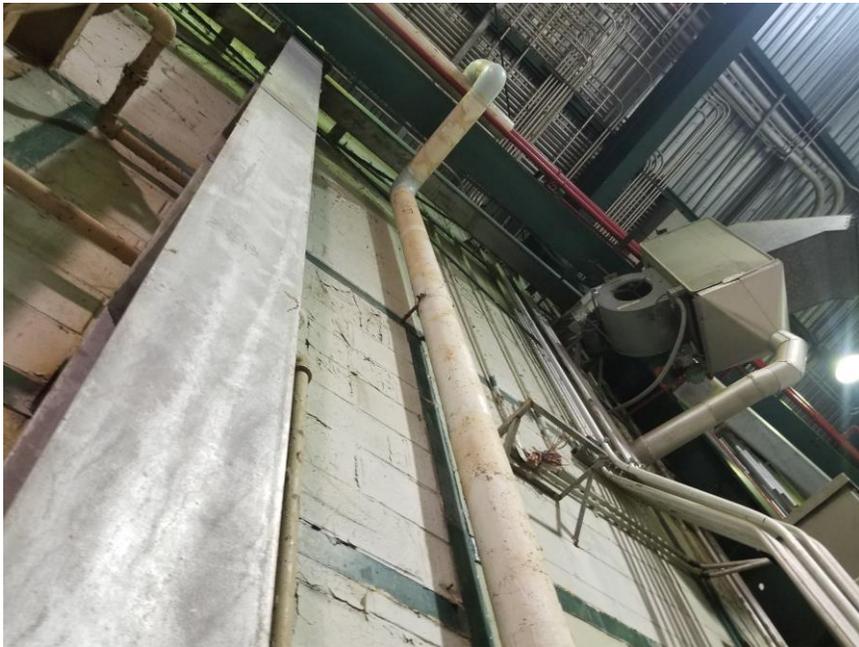
Photograph No. 3
View of HA – 03: Yellow 10" TSI with white wrap.

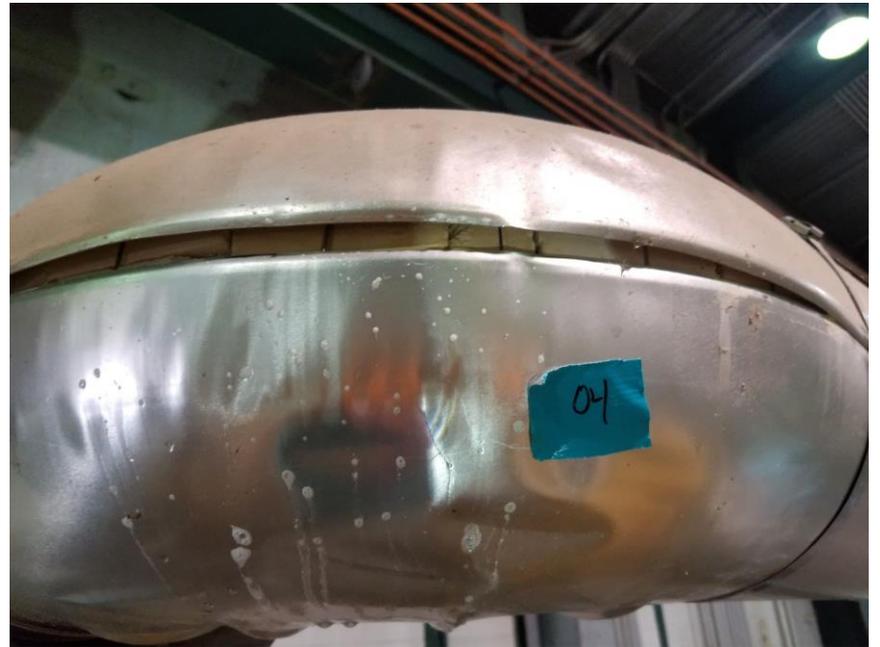
Photograph No. 4
View of HA – 04: Tan 10" pipe elbow under metal jacket

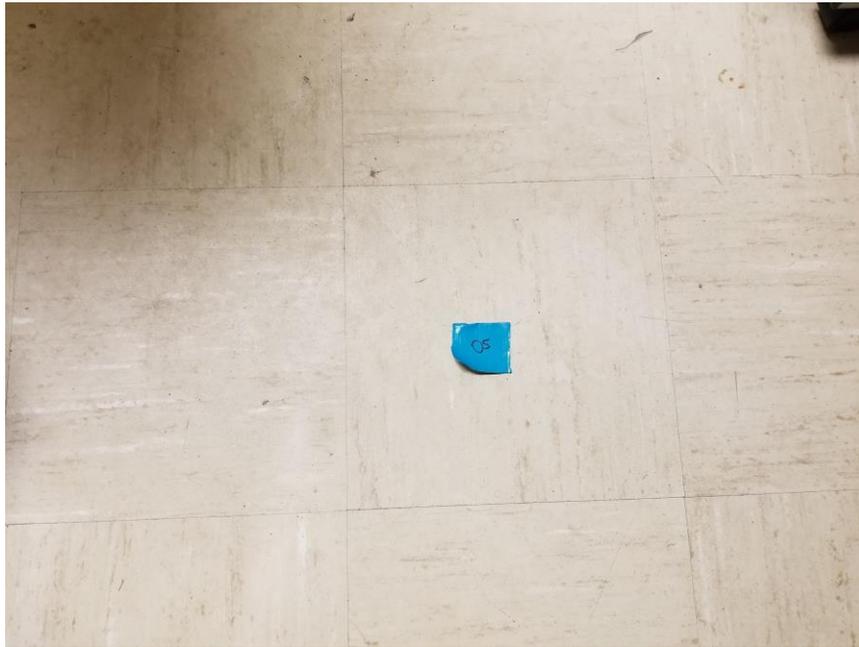
Photograph No. 5

View of HA – 05: Tan 12"x12" striped floor tile with brown mastic.

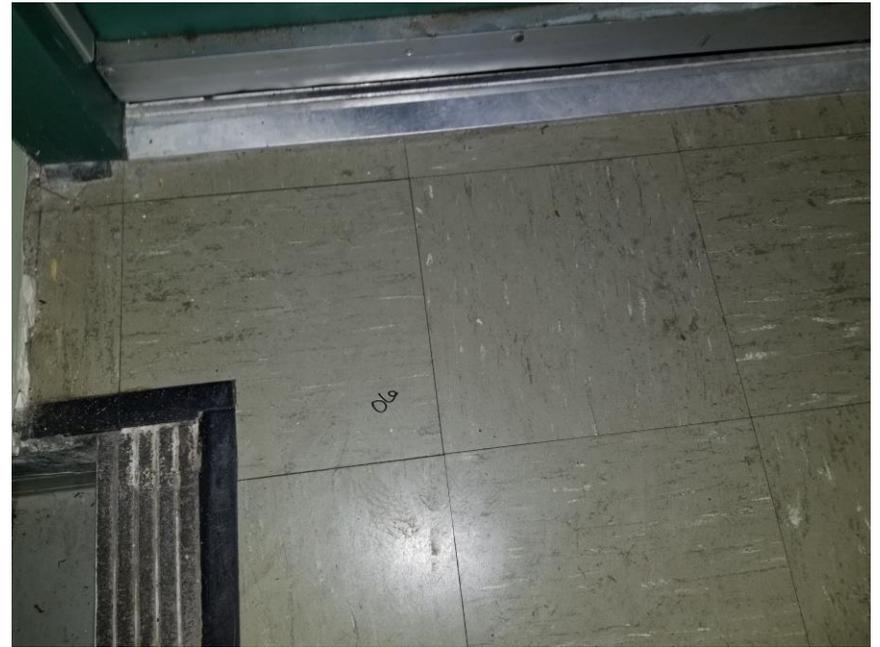
Photograph No. 6

The gray 9"x9" striped floor tile and associated black mastic within Level 2 of the Office was observed to be in good condition with a low potential for damage.

View of HA – 06: Gray 9"x9" striped floor tile and black mastic. Confirmed ACM.

- Category I Non-friable gray 9"x9" striped floor tile and black mastic within Level 2 of the Office: Terracon does not consider its presence an existing hazard at this time and noted a low potential for damage. These materials can be managed in-place such that they remain in good condition. The eventual abatement is recommended.
- Category II Non-friable white sink bottom coating within Level 2 of the Office: Terracon does not consider its presence an existing hazard at this time and noted

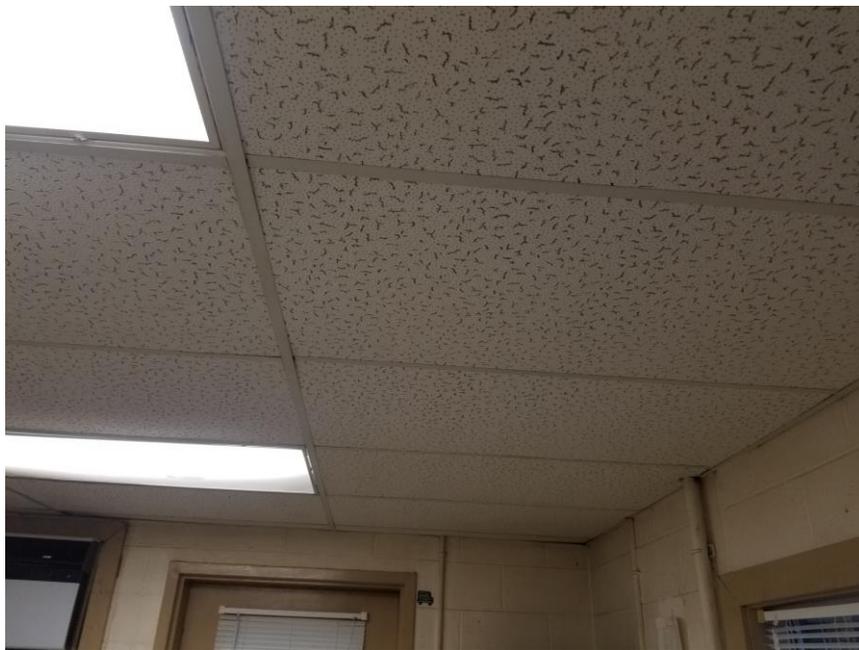
Photograph No. 7

View of HA – 07: White 2'x4' ceiling tiles.

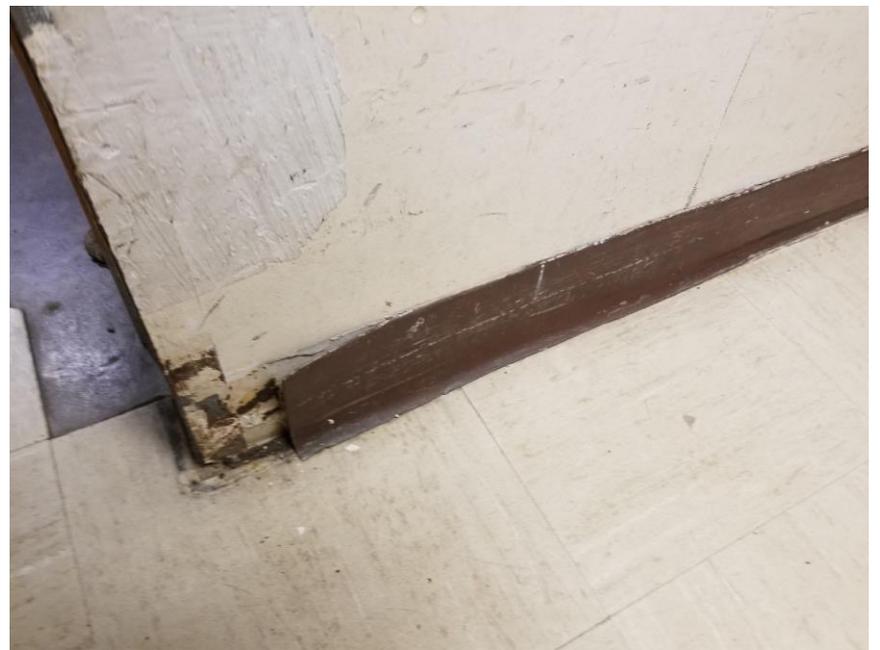
Photograph No. 8

View of HA – 08: Brown cove base mastic.

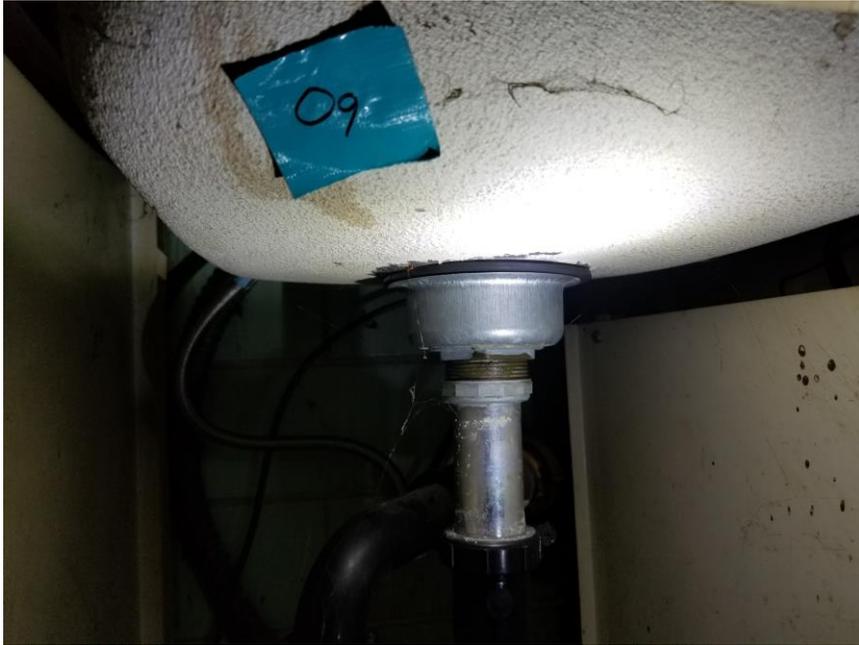
Photograph No. 9

The white sink bottom coating within Level 2 of the Office was observed to be in good condition with a low potential for damage.

View of HA - 09: White sink bottom coating. Confirmed ACM.

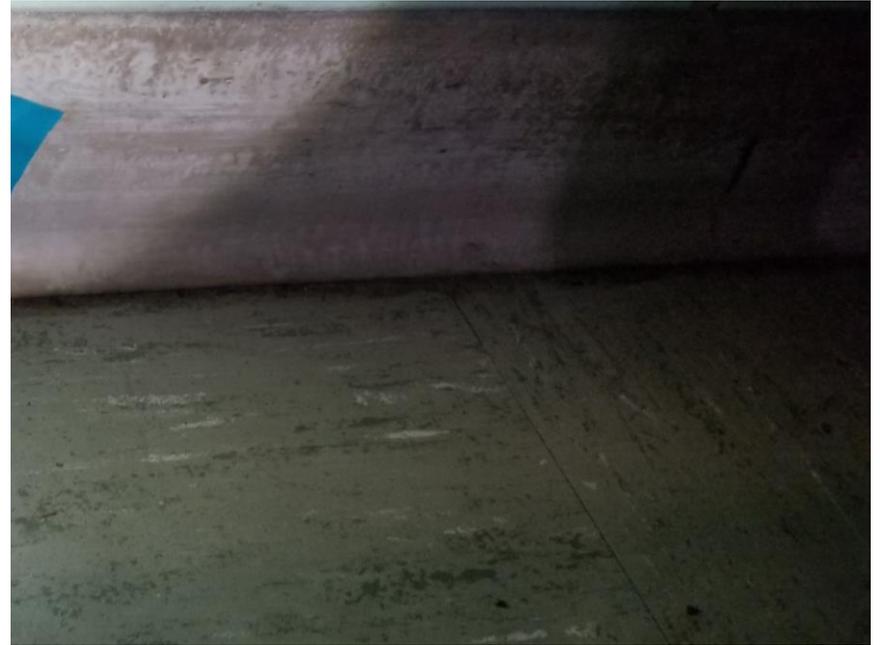
Photograph No. 10

View of HA - 10: Light brown 3" cove base with brown mastic.

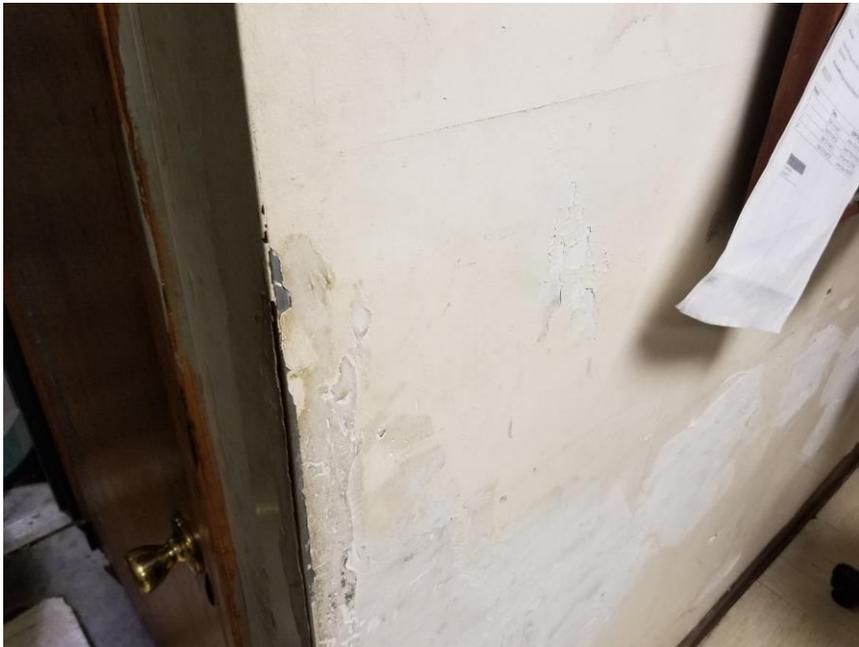
Photograph No. 11

View of HA - 11: White drywall and joint compound.

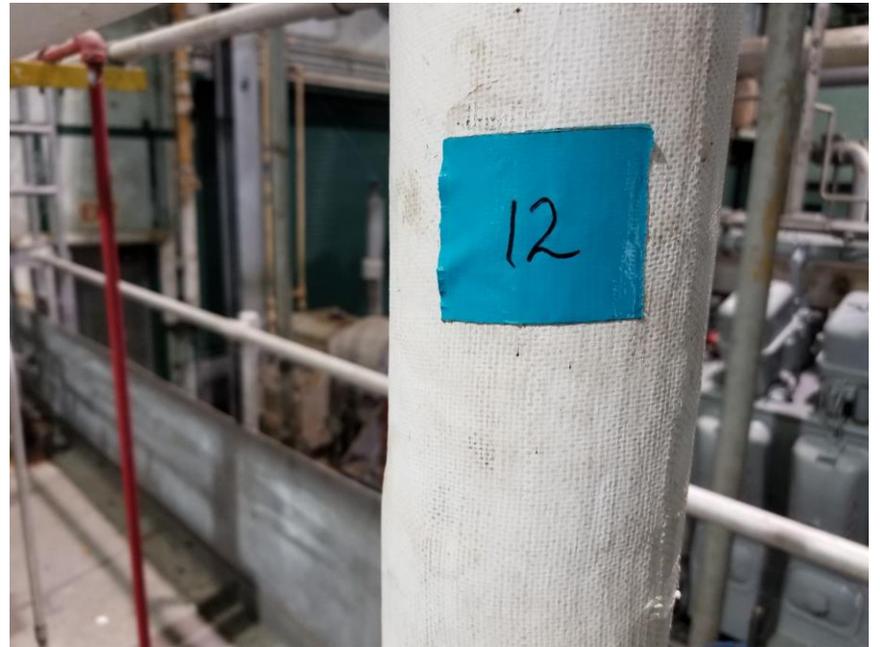
Photograph No. 12

View of HA - 12: White 6" TSI.

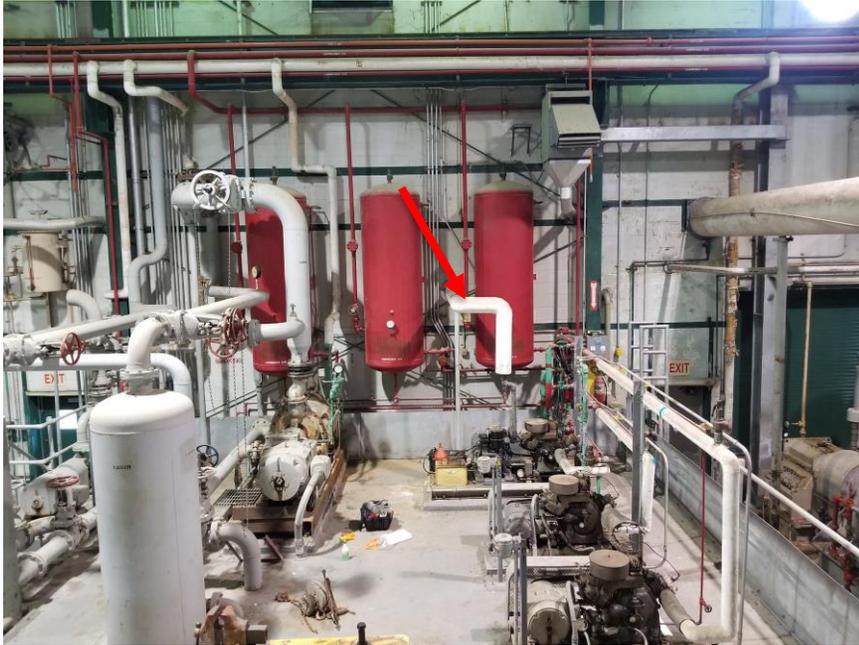
The 8" TSI associated with air compressor 3's (AC3) exhaust was observed to be significantly damaged at the time of the assessment. This is the only of the set of three air compressors that is diesel powered and therefore has an exhaust leading towards the building's exterior via a wall penetration.

Photograph No. 13
View of HA - 13: White 8" TSI. Confirmed ACM.

- RACM white 8" TSI between Pumps 5 & 6 and 18" TSI between Pumps 4 & 5: It is suspected that the mounting bracket penetrations through the TSI's jacket and vibration during operation caused this damage and could continue to release fibers into the environment. Therefore, Terracon recommends immediate repair and/or abatement of this material.
- The clutch pads associated with Pumps 4 and 5 are assumed ACM. The equipment associated with these materials is reportedly damaged and/or no longer in use. Due to their location, removal will require coordination between a licensed abatement contractor and SWBNO staff to access, remove, and dispose. It is recommended these materials be removed under the guidance of an operations and maintenance plan in conjunction with a specification.

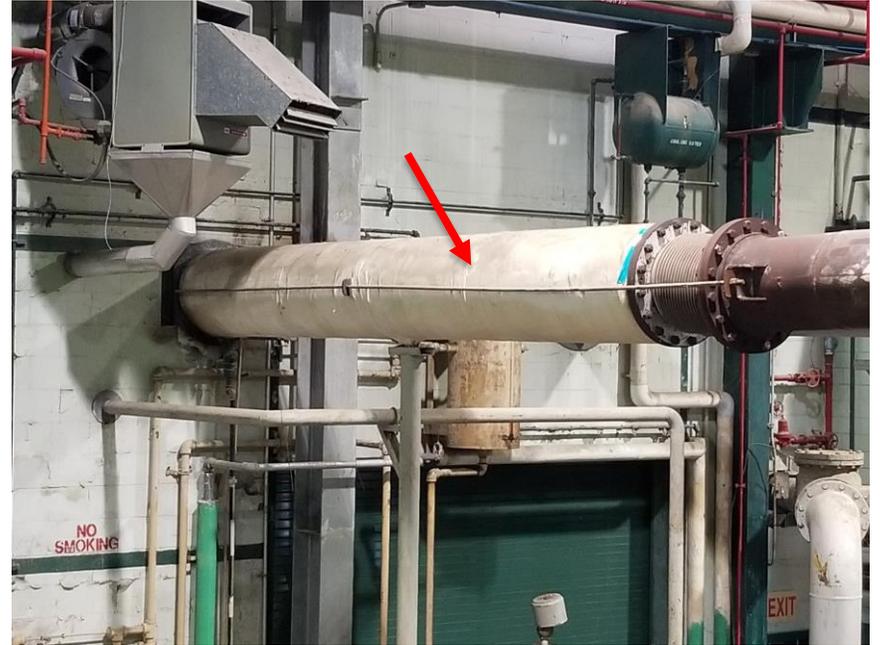
The two 18" TSI runs associated with Pump 4 & 5's exhausts were observed to be significantly damaged at the time of the assessment.

Photograph No. 14
View of HA - 14: White 18" TSI. Confirmed ACM.

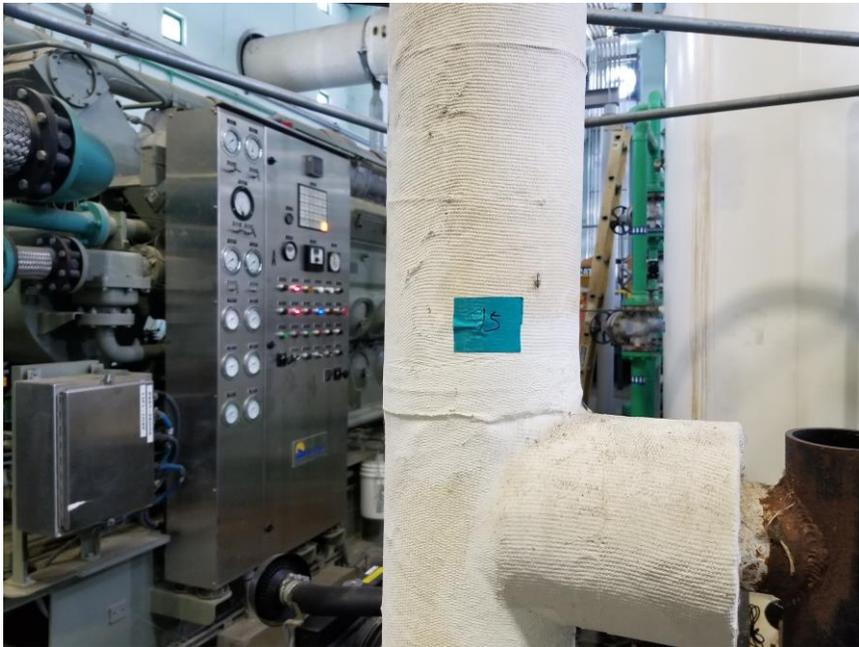
Photograph No. 15
View of HA - 15: White 8" TSI with coarse wrap.

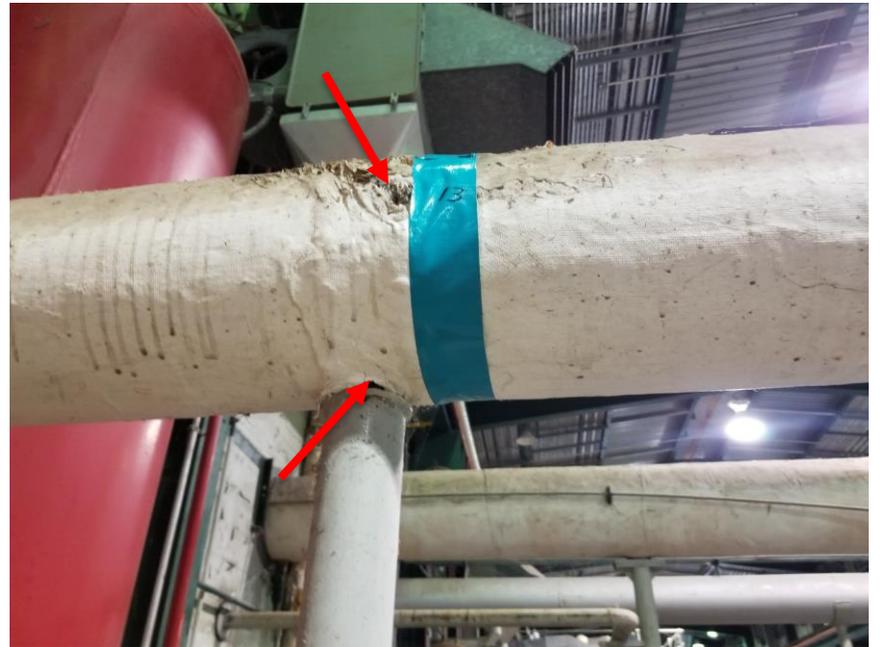
Photograph No. 16
View of damage in connection with white 8" TSI. Note support bracket penetration.

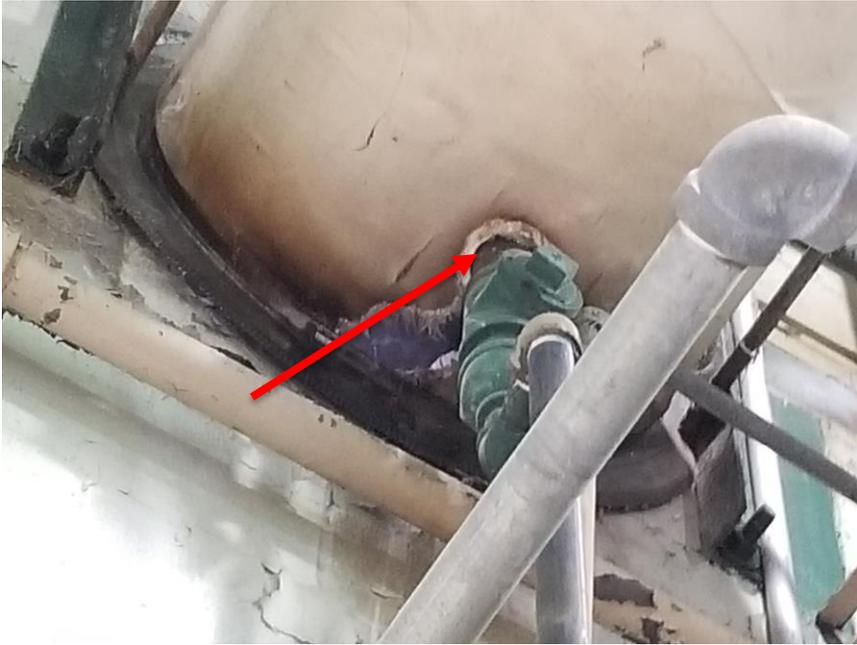
Photograph No. 17

View of white 18" TSI wall penetration. This is the area where undermining of ACM was observed.

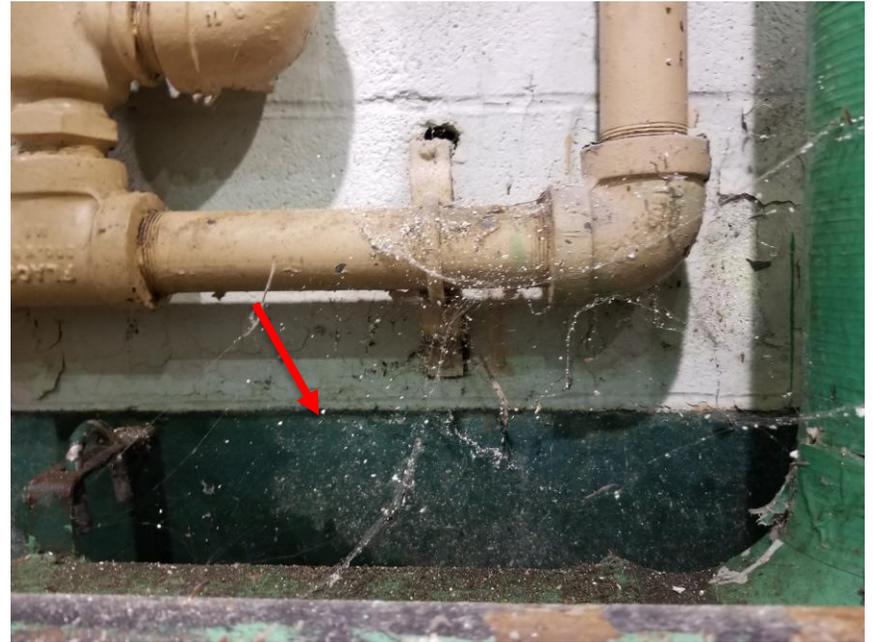
Photograph No. 18

View of debris beneath white 18" TSI associated with Pumps 4 and 5's exhausts.
