Attachment F - Elevated Tank Inspection Pictures - Pages 1-6
RFx 3000021987

APPENDIX A

PHOTOGRAPHS

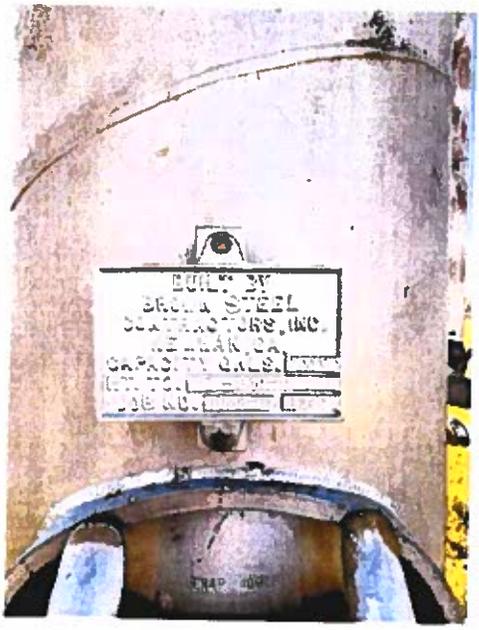
Tank Name Plate – good condition

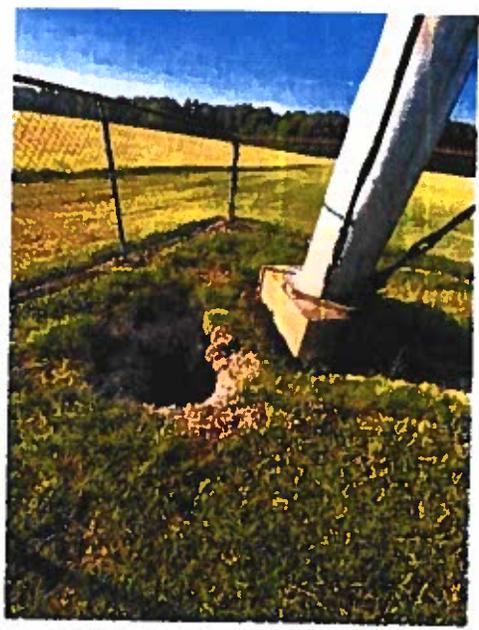
Erosion of tank foundation due to family of raccoons

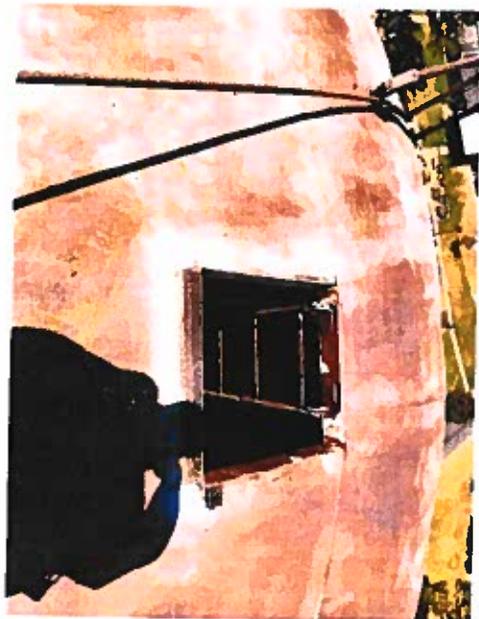
Roof Hatch – lid missing
Severe rusting – *This is completed 9-19-23*

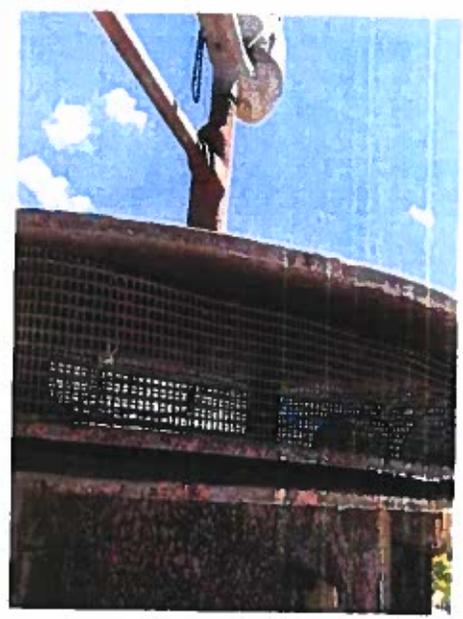
Roof Vent – Good condition
Severe Rusting
Vent Screen – good condition

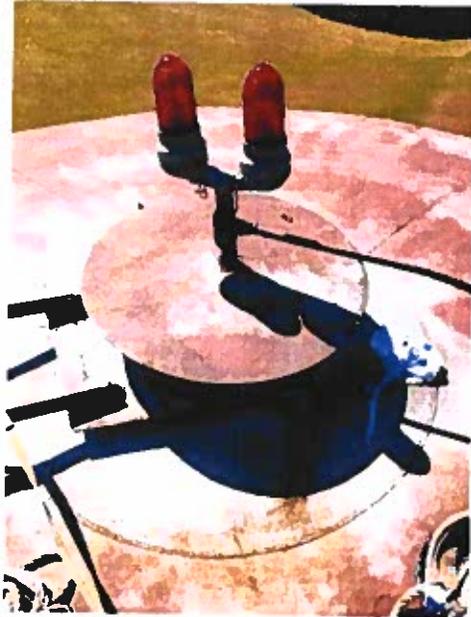
Lights – not working

Roof – Severe rusting and paint failure

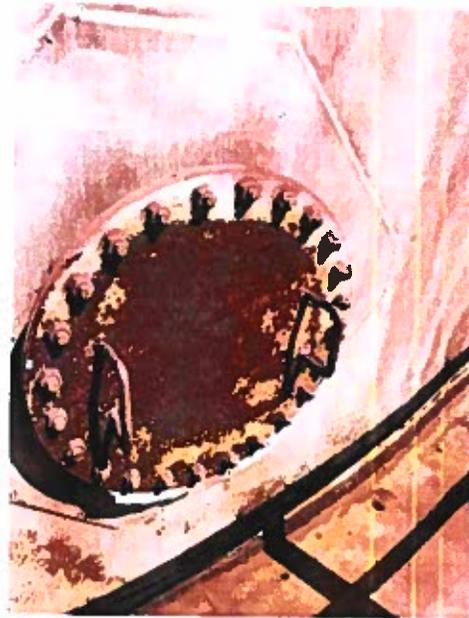
Balcony/Shell Manway – Good condition

Severe rusting

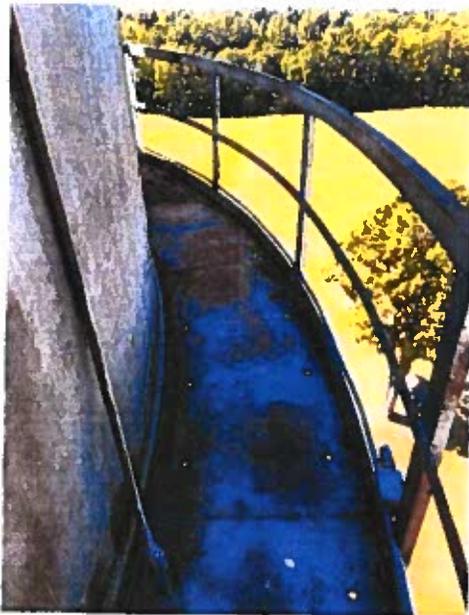
Balcony Floor – Severe rusting and ponding water.

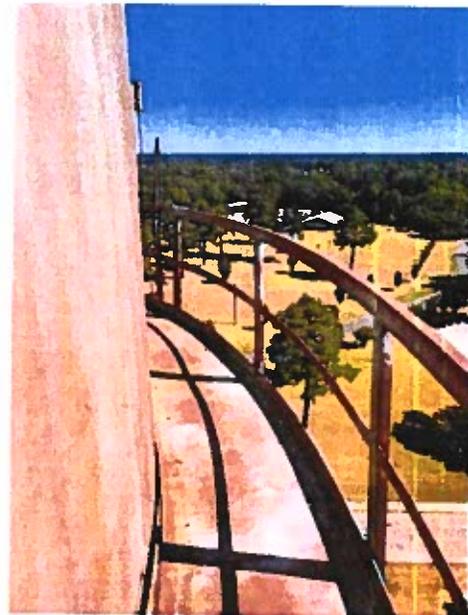
Balcony Railing – severe rusting

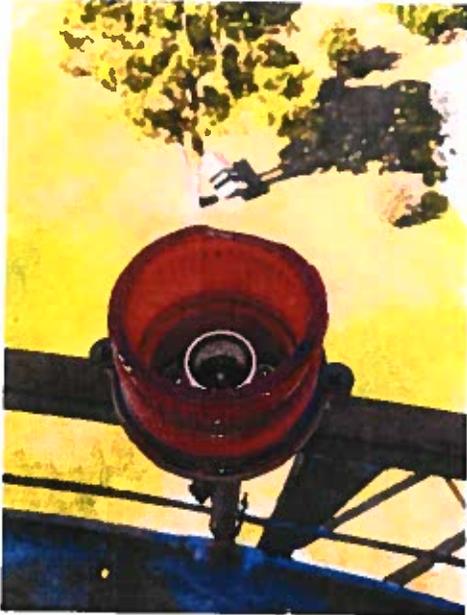
Broken Light globe located on the balcony handrails

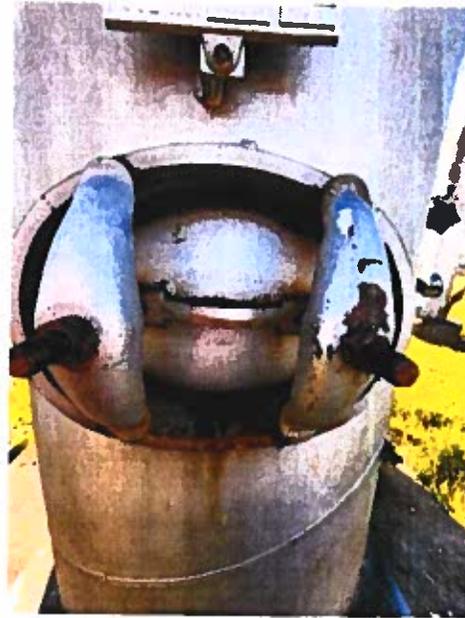
**Riser Manway – 16" oval
Severe rusting**

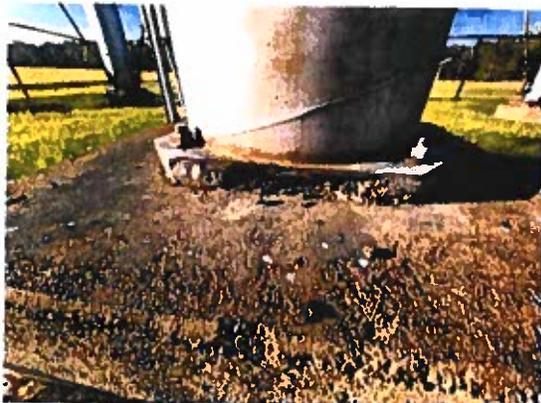
Foundations with missing concrete

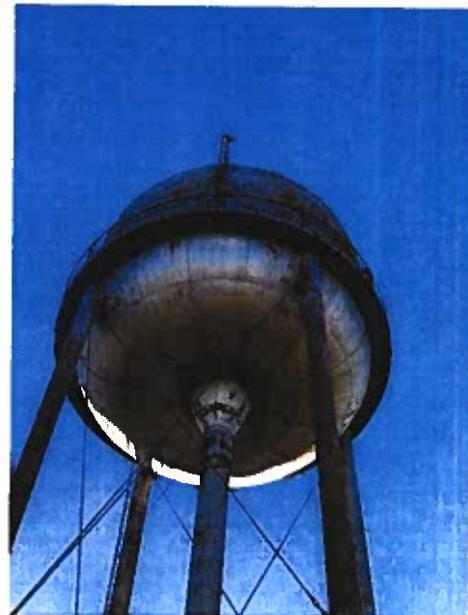
Exterior coating – poor condition

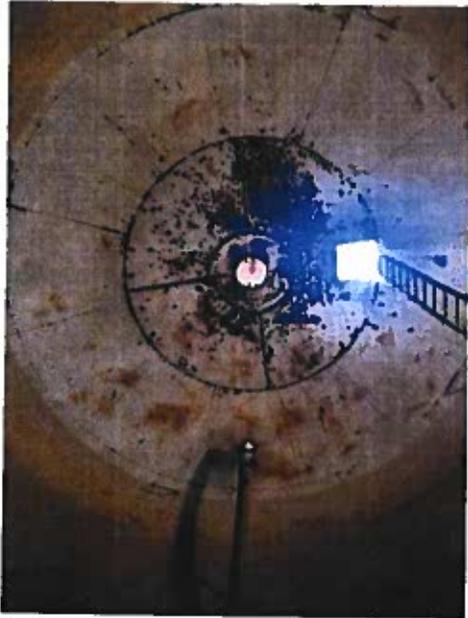
Interior Ceiling severe rusting

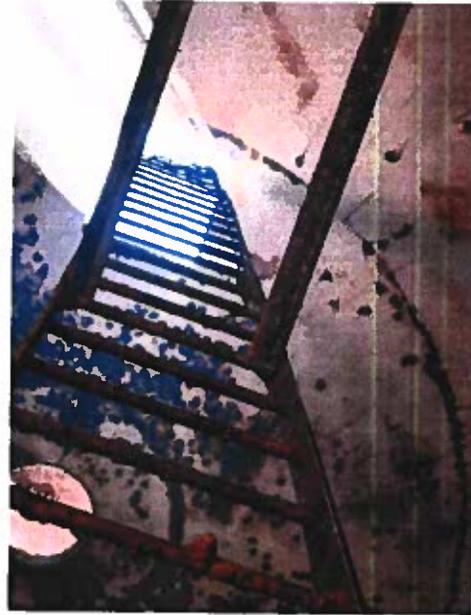
Interior Access ladder (roof to floor)
the top 10 feet are severely
deteriorated and need to be replaced

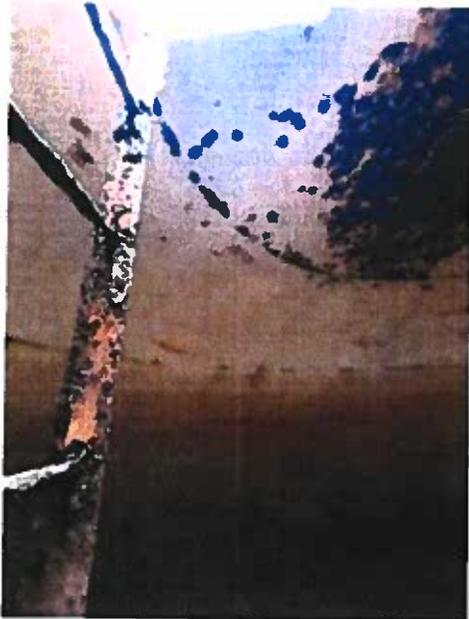
Interior Access Ladder – Deterioration

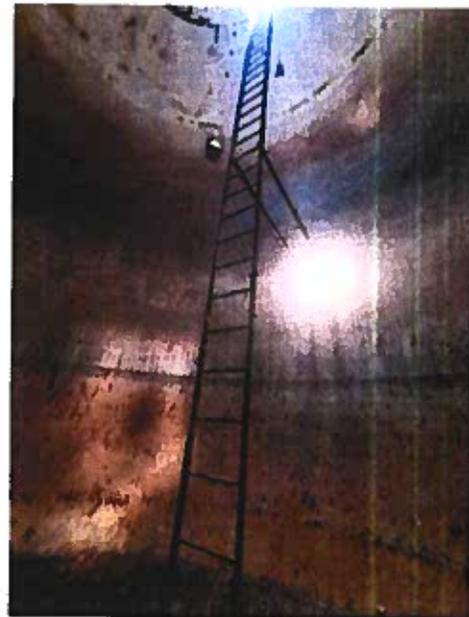
Bottom section of interior ladder –
good condition.

Severe rusting

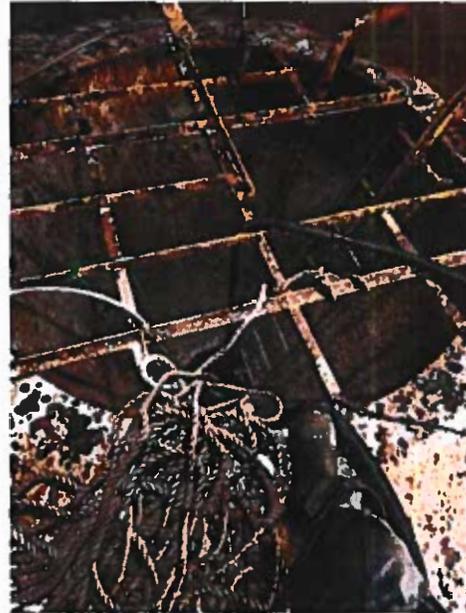
Riser Grating – deterioration and severe rusting
