Attachment B – Scope of Work

RFx No.: 3000023235

Title: *Mandatory-Site Visit* Vessel Repairs - LDWF

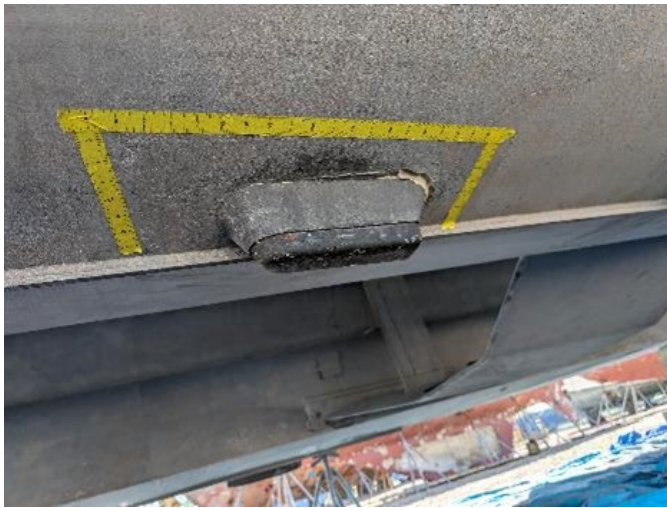
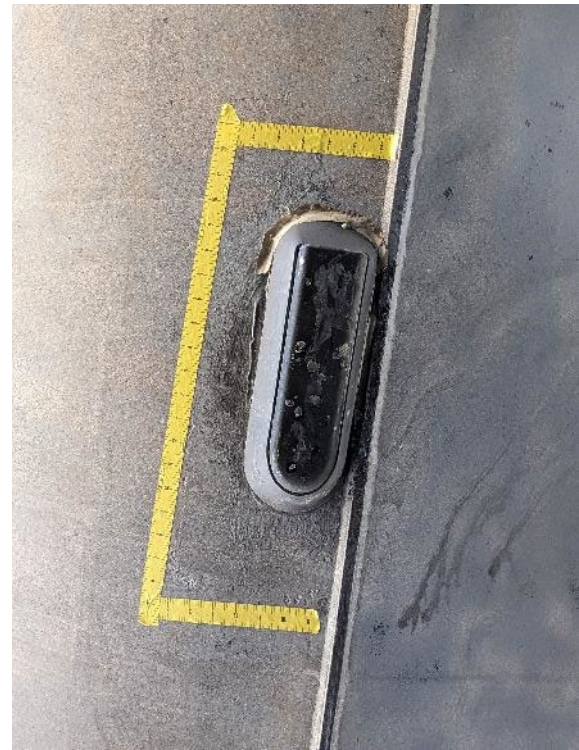
- Remove the depth transducer from the port hull mid-ship area. Crop out hull plating surrounding the penetration for the transducer approximately 2-ft. x 1-ft. area is marked in photographs. Re-plate as original. Reinstall transducer and test operation.

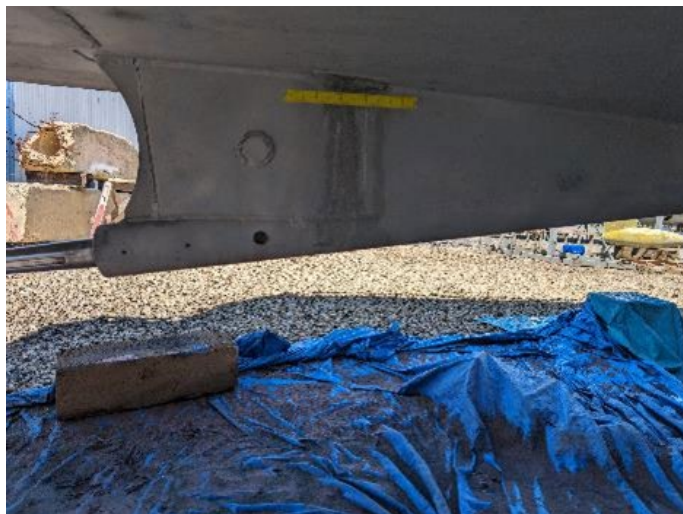
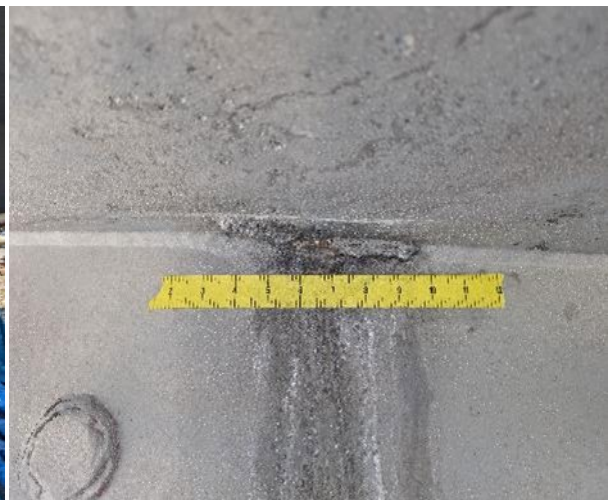
- Port side hull where shaft Skeg is attached to the hull is an area previously repaired. Grind off previous weld repair and the well as needed. Possible re-plating or doubler plate may need to be installed to complete this repair properly.

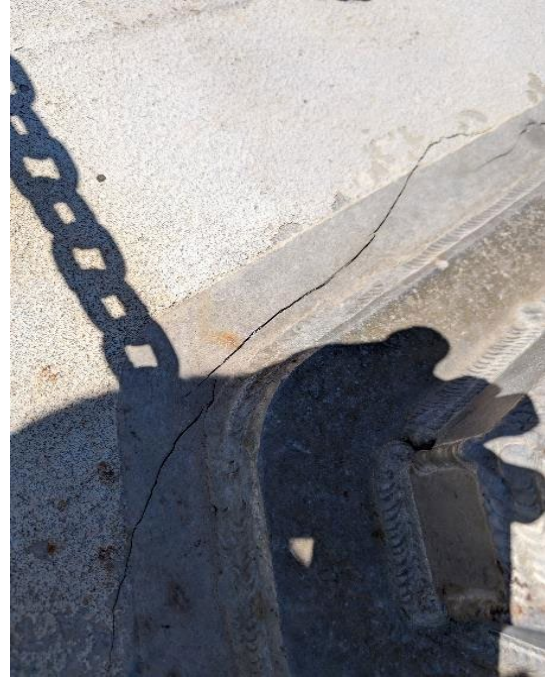
- On the fore deck is a 36" x 36" raised mounting platform triangular shape. Areas of stress cracking in the hull plating surrounding this structure. Deck plating is to be cut out outside of the stress cracks and then the deck re-plated without the mounting plate. On completion non-skid compound to be reapplied to the deck on the new plating.
