Attachment B – Scope of Work

RFx No.: 3000023440

Title: *Rebid*Mand.SiteVisit*Vessel Repair-LDWF

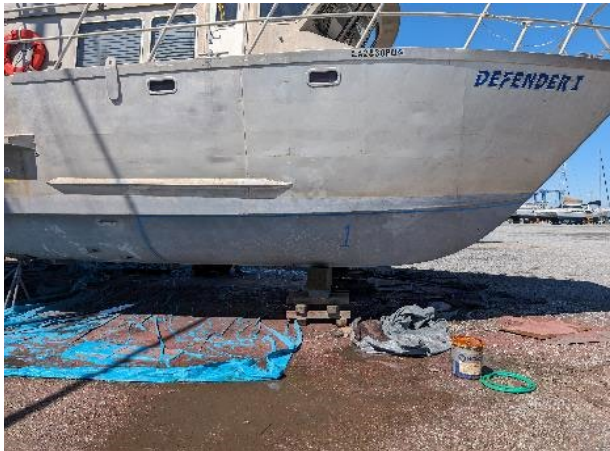
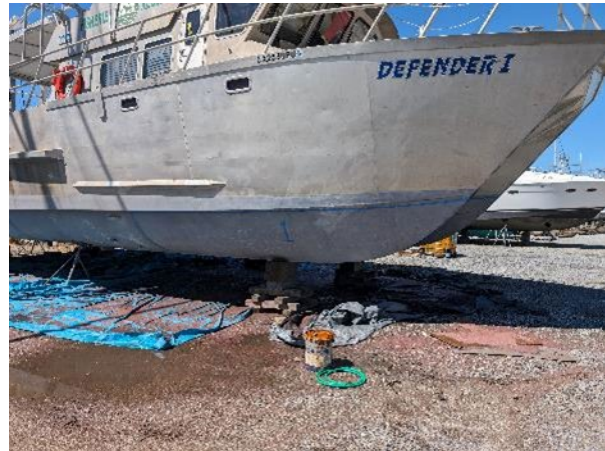
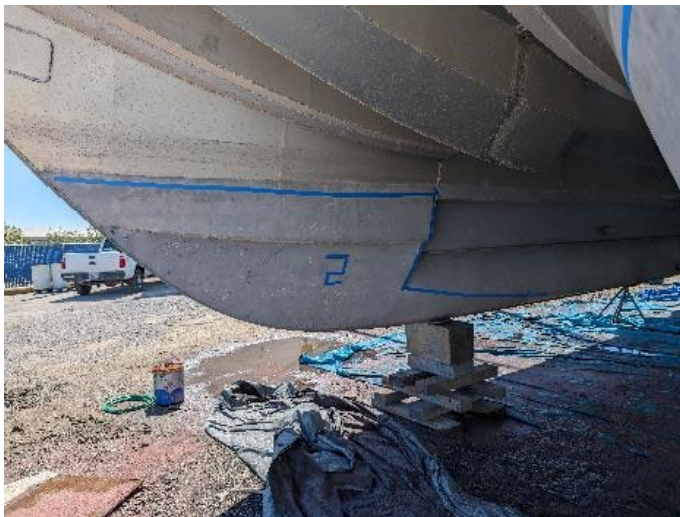
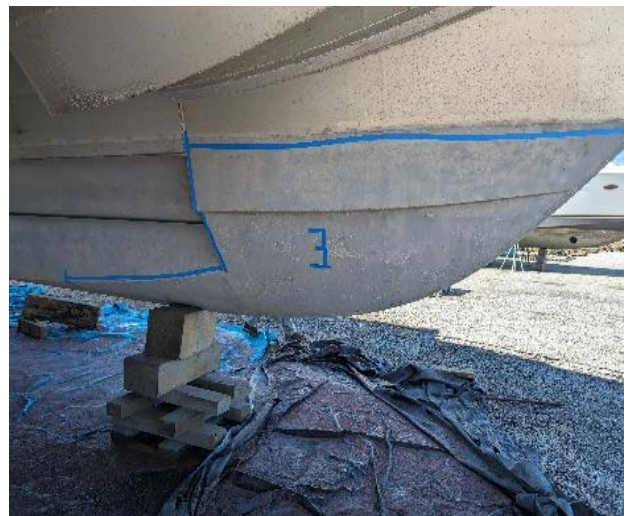
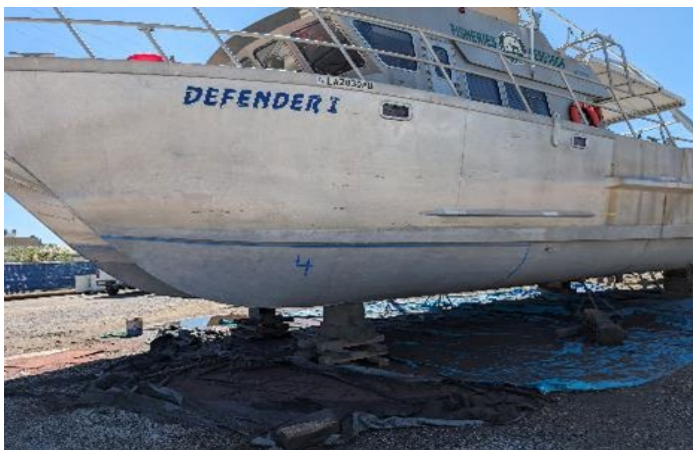
- Areas shown in the photographs marked 1 through 4:

- * Area 1: Starboard hull re-plating approximately 18-ft. section from bow stem aft and from chine down to keel.
- * Area 2: Starboard hull re-plating from weld joint along chine from bow stem aft and down to the keel following features in the hull as shown in the photograph.
- * Area 3: Port hull re-plating from weld joint along chine from bow stem aft and down to the keel following the features in the hull as shown in the photographs.
- * Area 4: Port hull re-plating approximately 17.5-ft. section from the bow stem aft and from chine down to the keel and shown in the photographs.

- Four areas marked out on the port hull and starboard hull areas to be re-plated as original. Crop back original plating to structural members. Reform and weld new plating in place conforming to standard welding procedures.
- This repair estimate is to include disassembly and reassembly of interior cabinetry, bulkheads and joinery work in the two forward stateroom areas to provide access to the interior hull structures so that welding can be completed to these interior hull structures.

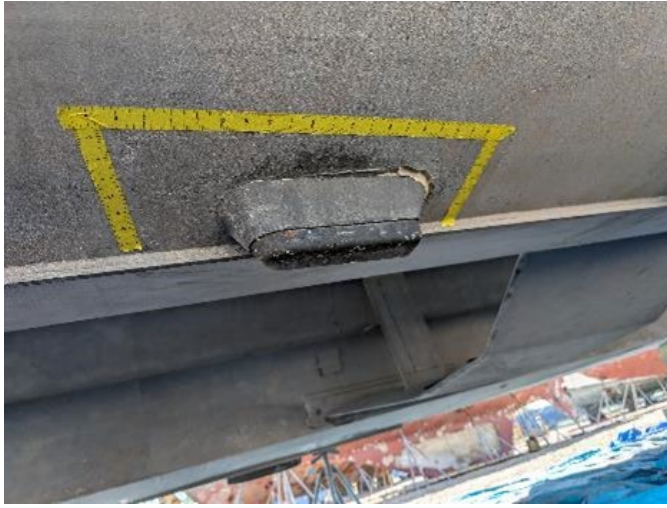
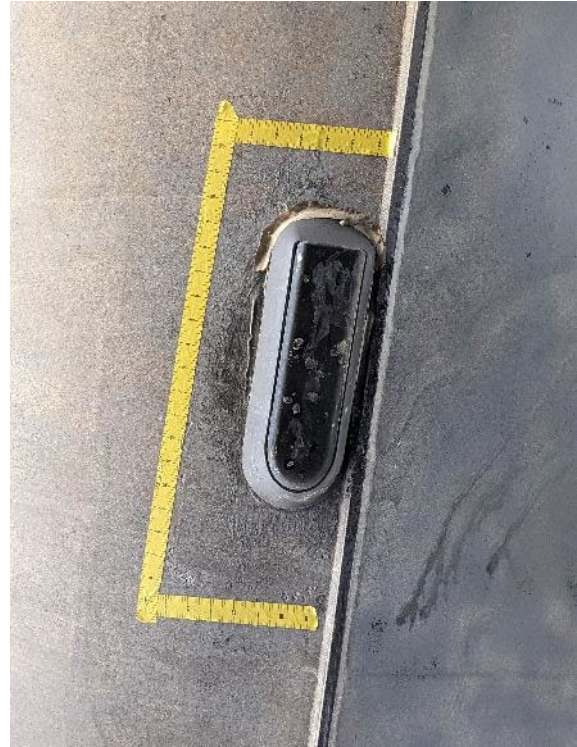
- Remove the depth transducer from the port hull mid-ship area. Crop out hull plating surrounding the penetration for the transducer approximately 2-ft. x 1-ft. area is marked in photographs. Re-plate as original. Reinstall transducer and test operation.

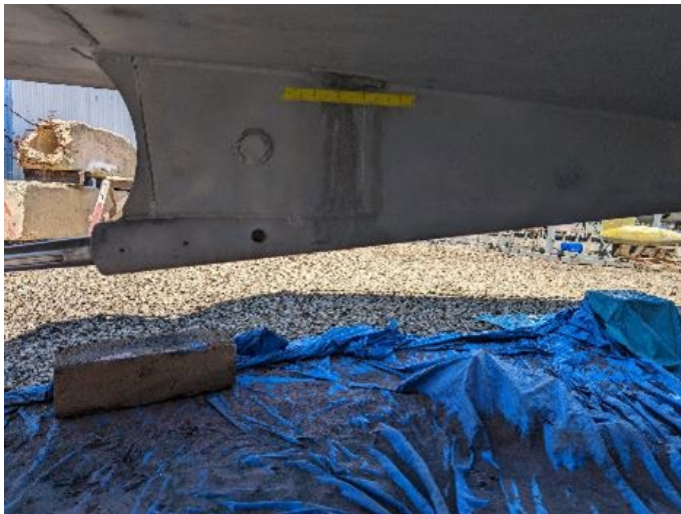
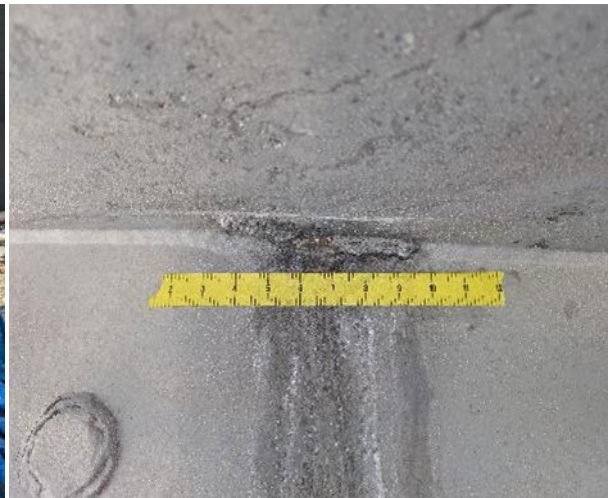
- Port side hull where shaft Skeg is attached to the hull is an area previously repaired. Grind off previous weld repair and the well as needed. Possible re-plating or doubler plate may need to be installed to complete this repair properly.

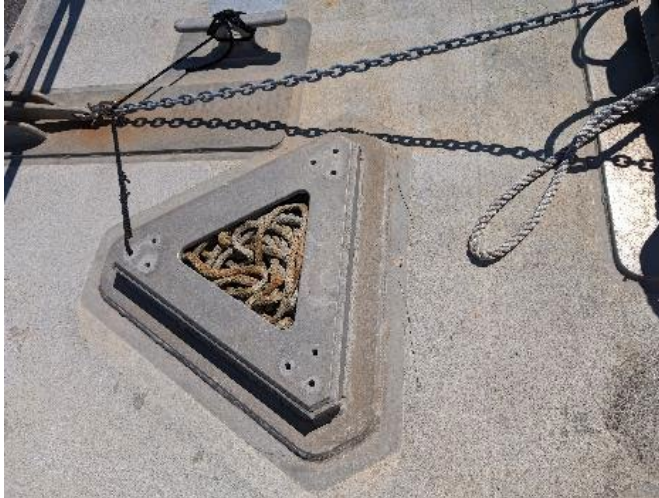
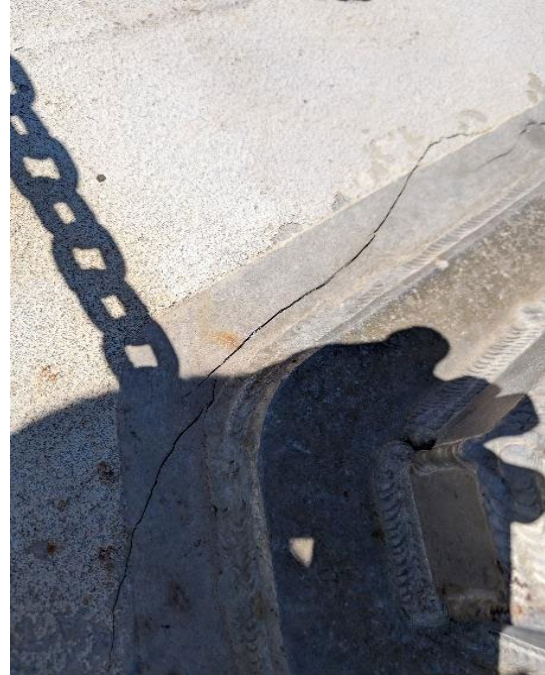
- On the fore deck is a 36" x 36" raised mounting platform triangular shape. Areas of stress cracking in the hull plating surrounding this structure. Deck plating is to be cut out outside of the stress cracks and then the deck re-plated without the mounting plate. On completion non-skid compound to be reapplied to the deck on the new plating.

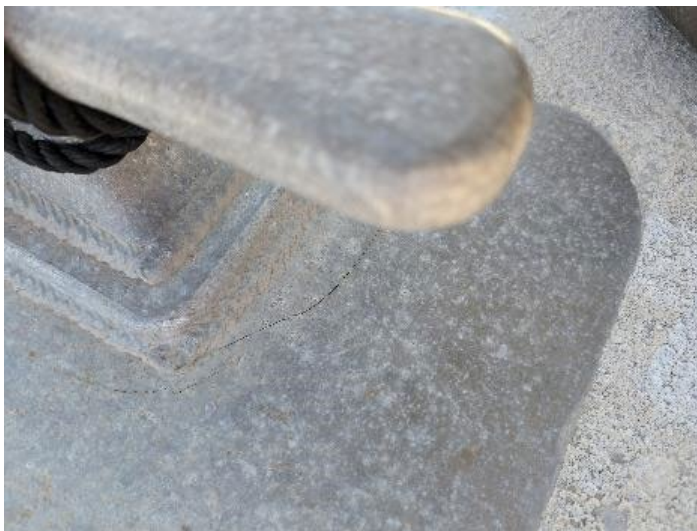
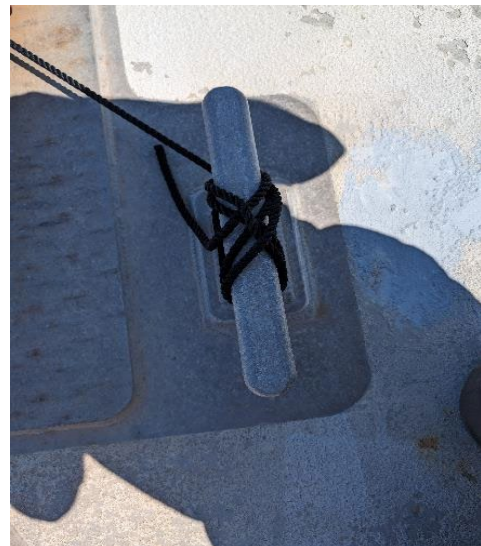
- Starboard side fore deck is a 15" aluminum mooring cleat. Cleat is welded to a doubler plate which is then welded to the deck. There is stress cracking around the perimeter of the doubler plate on the deck plating. Deck plating outside of the stress cracks to be cropped out and then re-plated as original. Original cleat to be re-welded in place as original.
