**Addendum No.:** 1

**Bid#:** 24-52-2

**Project Name:** Structure Demolition and Slab Removal

St. Tammany Buyout Program – 1113 Schech Dr. – Lead Based Paint Inspection

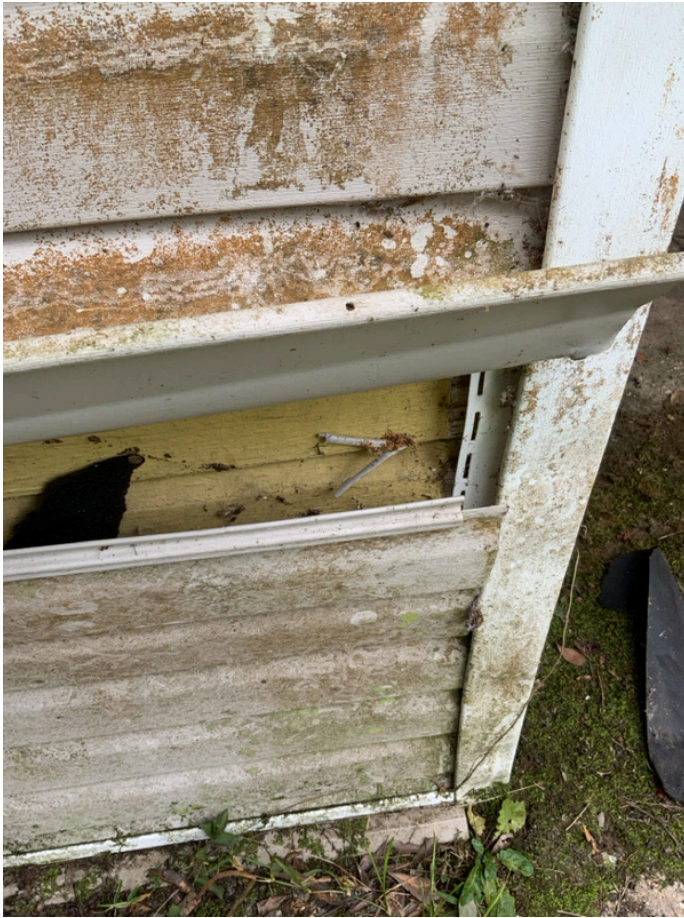
XRF Shot #	27
Area (XRF)	Exterior
Room (XRF)	
Building Feature (XRF)	Wall
Component (XRF)	Wall A
Substrate (XRF)	Wood
Location (XRF)	A
Paint Color (XRF)	Yellow
Condition (XRF)	Cracking
XRF Result: (mg/cm <sup>2</sup> )	1.2
Lead Present:	Yes

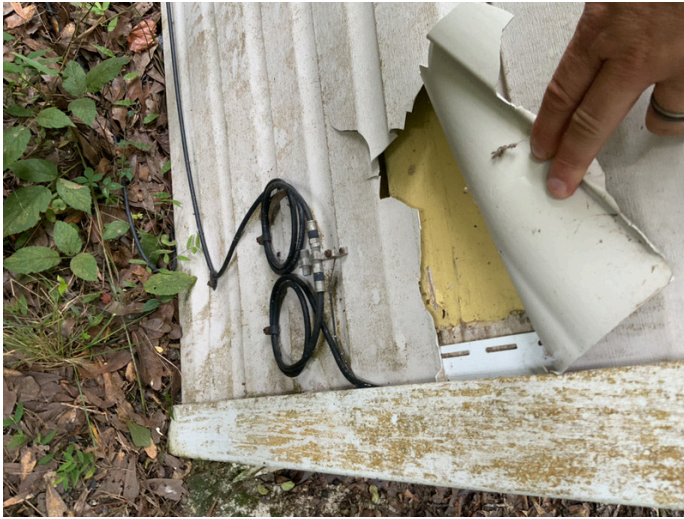
XRF Shot #	28
Area (XRF)	Exterior
Room (XRF)	
Building Feature (XRF)	Wall
Component (XRF)	Wall
Substrate (XRF)	Wood
Location (XRF)	B
Paint Color (XRF)	Yellow
Condition (XRF)	Cracking
XRF Result: (mg/cm <sup>2</sup> )	1.2
Lead Present:	Yes

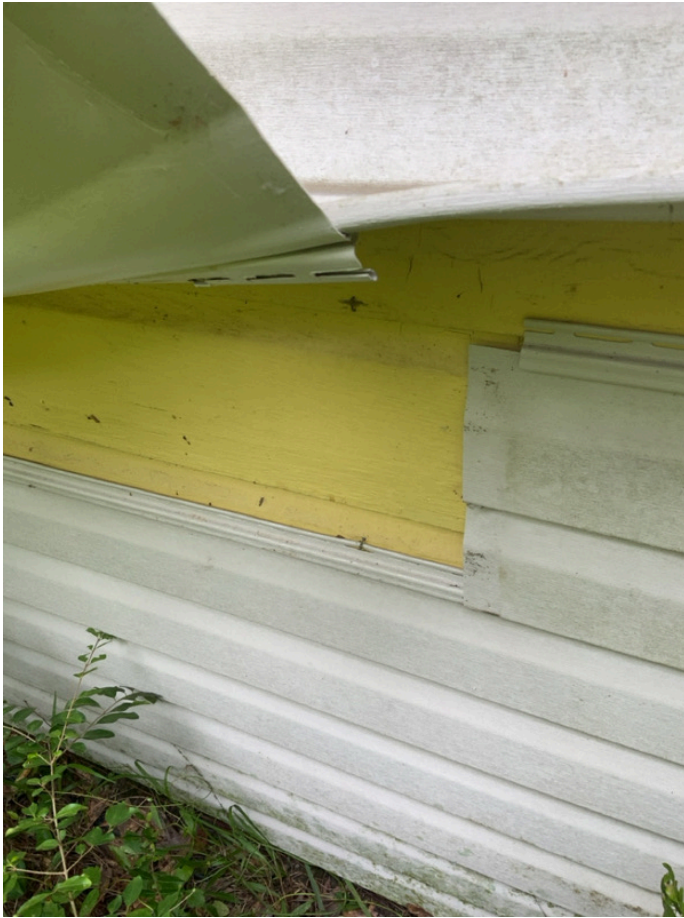
XRF Shot #	29
Area (XRF)	Exterior
Room (XRF)	
Building Feature (XRF)	Wall
Component (XRF)	Wall
Substrate (XRF)	Wood
Location (XRF)	C
Paint Color (XRF)	Yellow
Condition (XRF)	Impact Friction
XRF Result: (mg/cm <sup>2</sup> )	1.3
Lead Present:	Yes

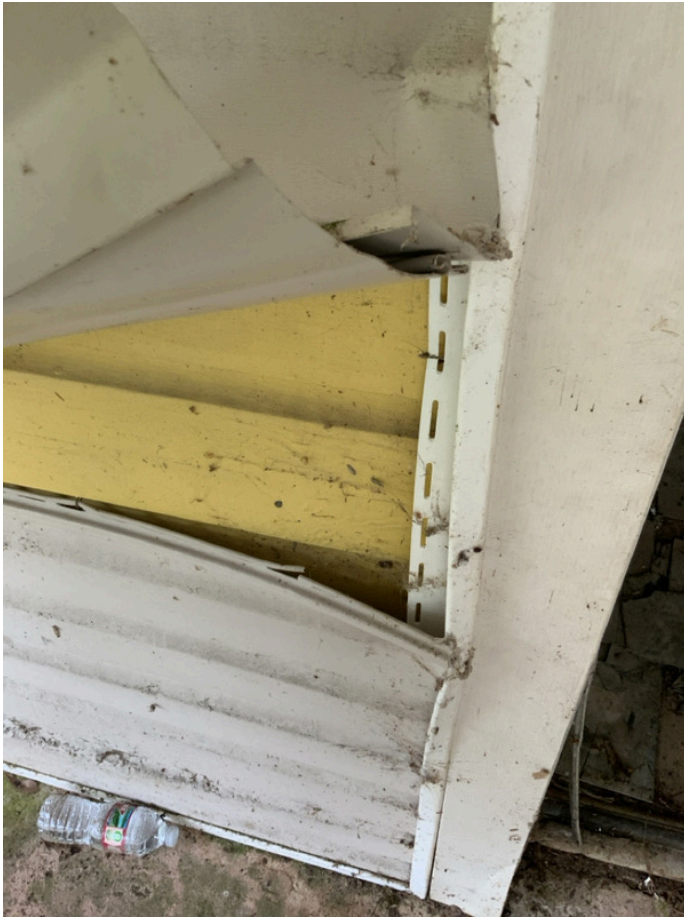
XRF Shot #	30
Area (XRF)	Exterior
Room (XRF)	
Building Feature (XRF)	Wall
Component (XRF)	Wall
Substrate (XRF)	Wood
Location (XRF)	D
Paint Color (XRF)	Yellow
Condition (XRF)	Impact Friction
XRF Result: (mg/cm <sup>2</sup> )	1.1
Lead Present:	Yes

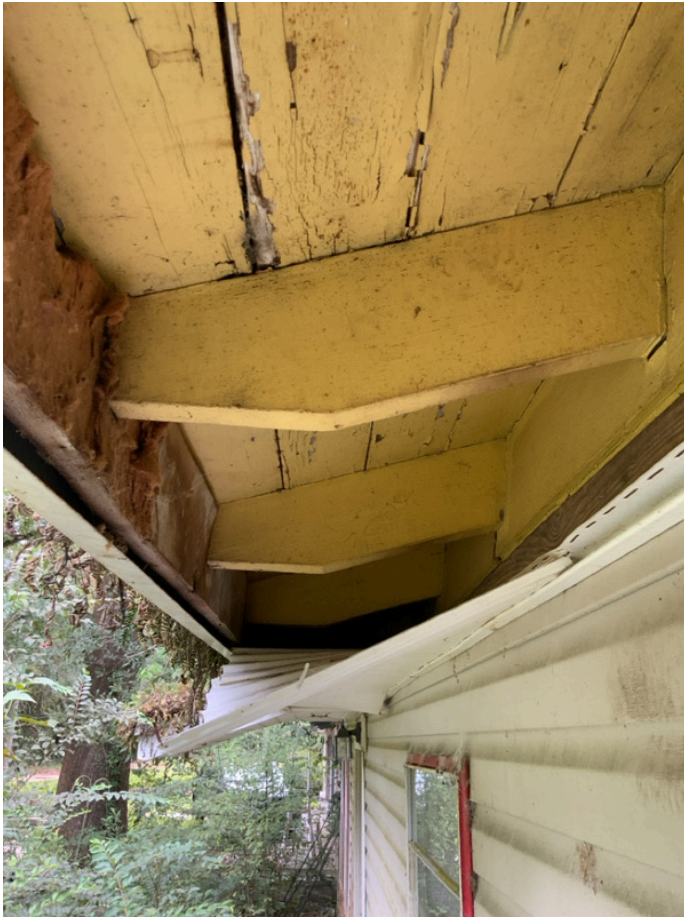
XRF Shot #	31
Area (XRF)	Exterior
Room (XRF)	
Building Feature (XRF)	Roof
Component (XRF)	Soffit
Substrate (XRF)	Wood
Location (XRF)	A
Paint Color (XRF)	Yellow
Condition (XRF)	Impact Friction
XRF Result: (mg/cm <sup>2</sup> )	1.2
Lead Present:	Yes

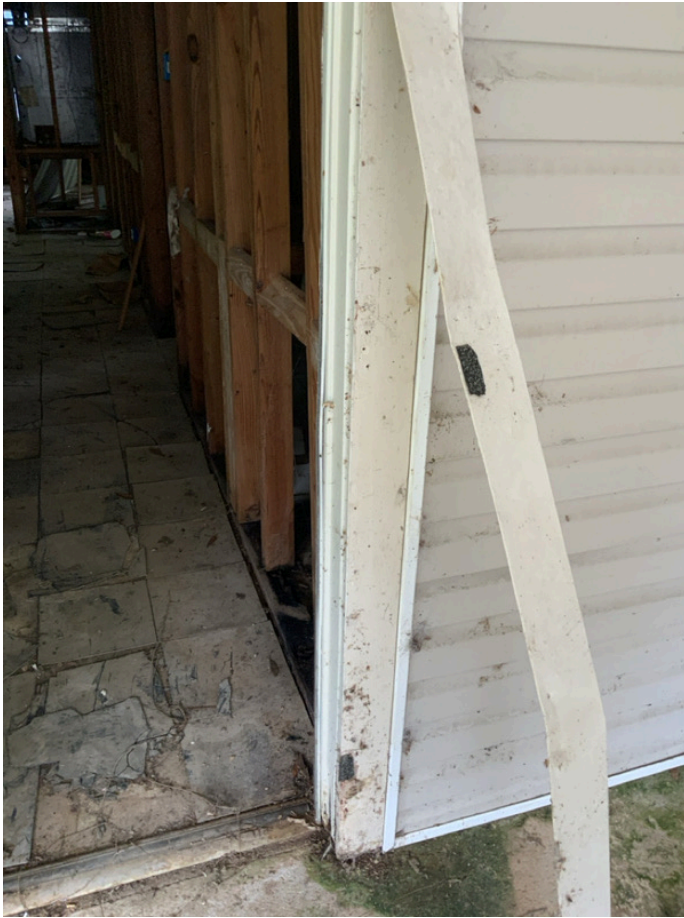
XRF Shot #	34
Area (XRF)	Exterior
Room (XRF)	
Building Feature (XRF)	Dwelling Entrance
Component (XRF)	Casing
Substrate (XRF)	Wood
Location (XRF)	D
Paint Color (XRF)	White
Condition (XRF)	Impact Friction
XRF Result: (mg/cm <sup>2</sup> )	1.2
Lead Present:	Yes

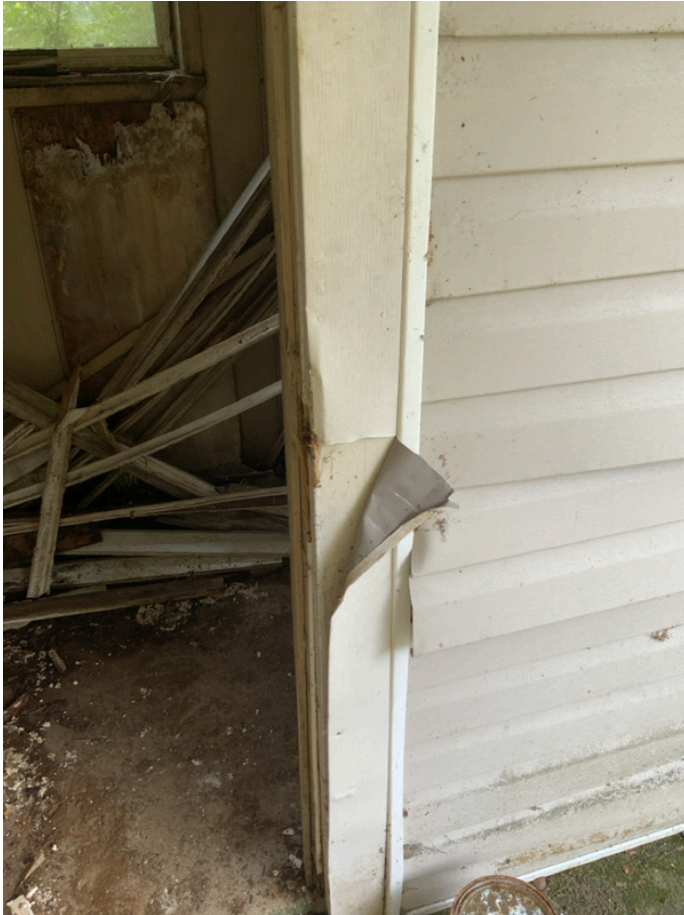
Room (XRF)	Laundry
Building Feature (XRF)	Room Equivalent Entrance
Component (XRF)	Casing
Substrate (XRF)	Wood
Location (XRF)	A
Paint Color (XRF)	White
Condition (XRF)	Impact Friction
XRF Result: (mg/cm <sup>2</sup> )	1.2
Lead Present:	Yes

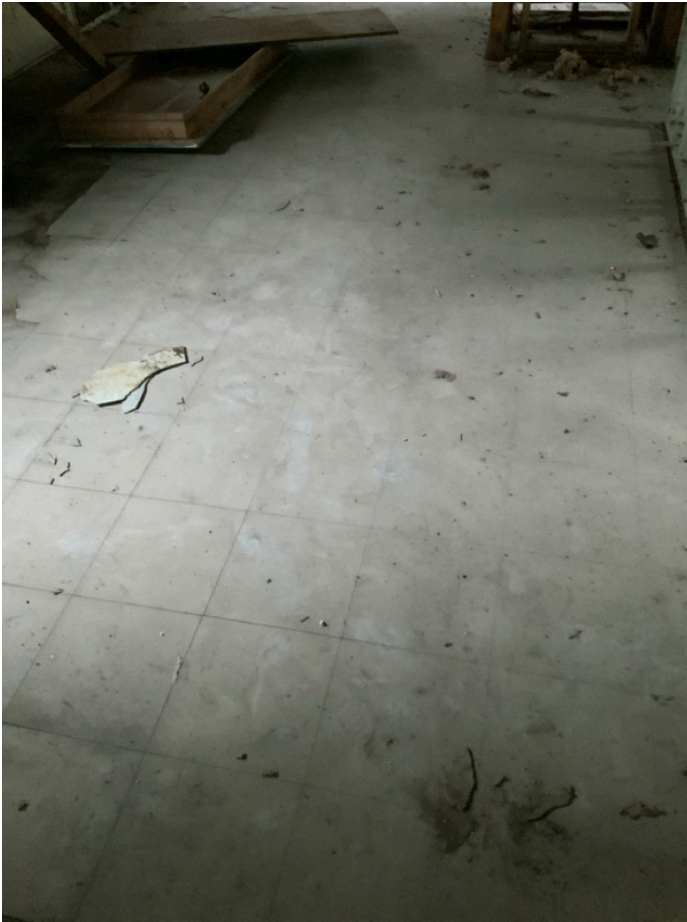
**Materials - 1. Floor Tiles**

Material Color	Beige
Material Locations	All rooms
Quantity	800
Units	Sq Ft
Condition	Poor
Friability	Friable

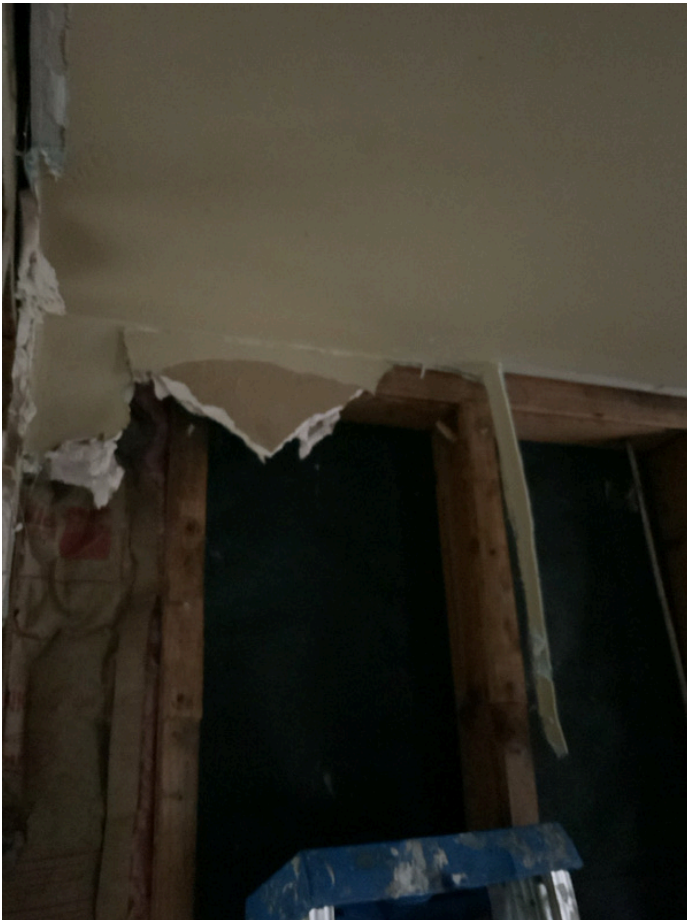
Homogenous Area #	2
Material Type	Dry Wall

Material Color	Blue
Material Locations	All rooms
Quantity	200

Units	Sq Ft
Condition	Poor
Friability	Friable

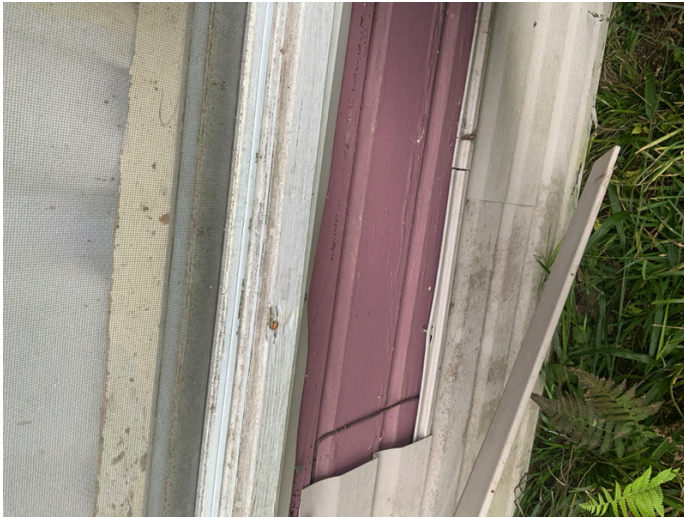
Component (XRF)	Wall
Substrate (XRF)	Wood
Location (XRF)	A
Paint Color (XRF)	Pink
Condition (XRF)	Impact Friction
XRF Result: (mg/cm <sup>2</sup> )	1.3
Lead Present:	Yes

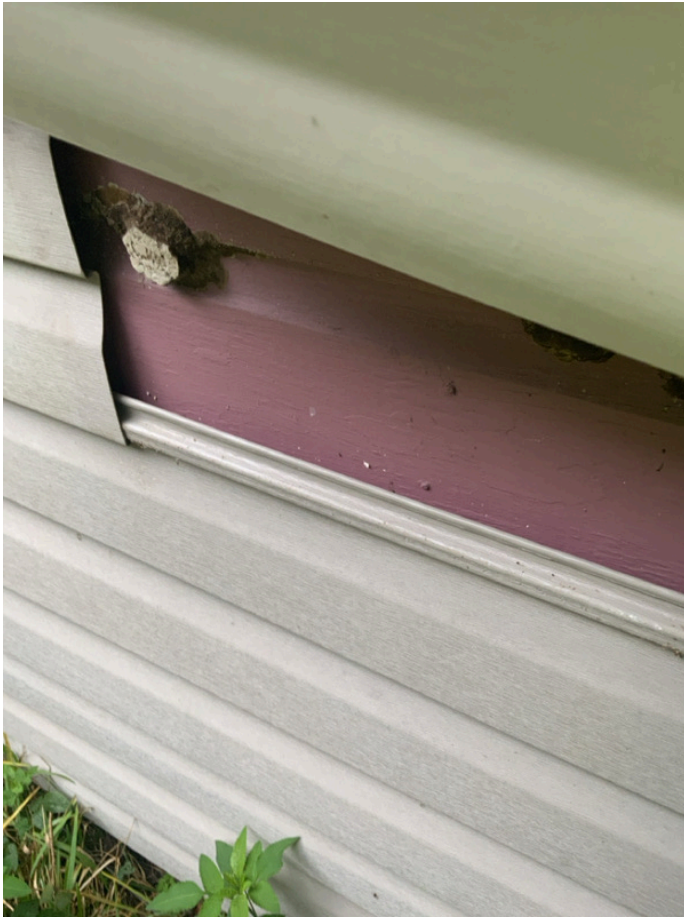
XRF Shot #	26
Area (XRF)	Exterior
Room (XRF)	
Building Feature (XRF)	Wall
Component (XRF)	Wall
Substrate (XRF)	Wood
Location (XRF)	B
Paint Color (XRF)	Pink
Condition (XRF)	Impact Friction
XRF Result: (mg/cm <sup>2</sup> )	1.2
Lead Present:	Yes

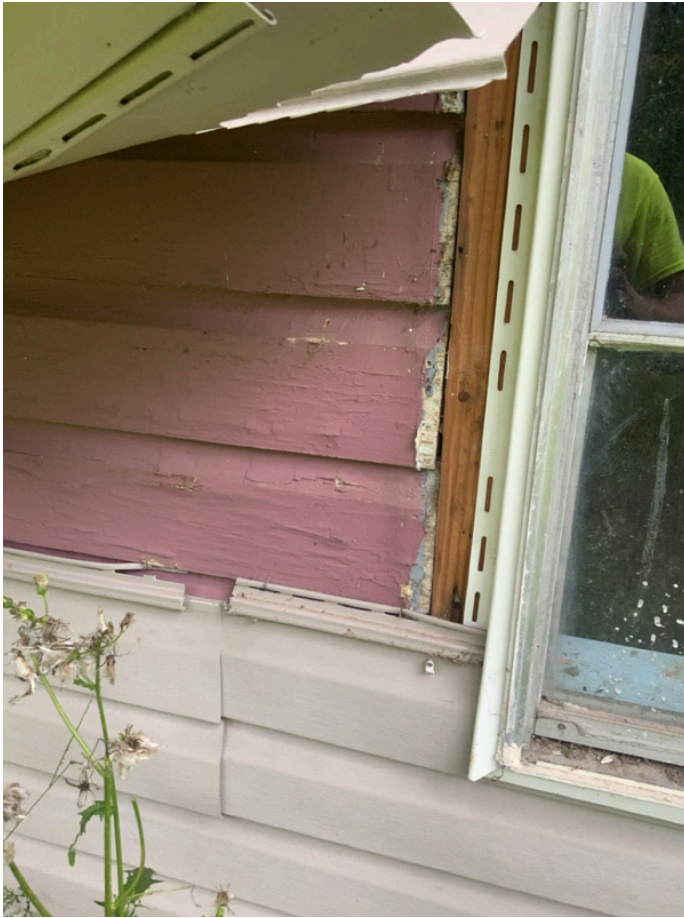
XRF Shot #	27
Area (XRF)	Exterior
Room (XRF)	
Building Feature (XRF)	Wall
Component (XRF)	Wall
Substrate (XRF)	Wood
Location (XRF)	C
Paint Color (XRF)	Pink
Condition (XRF)	Impact Friction
XRF Result: (mg/cm <sup>2</sup> )	1.2
Lead Present:	Yes

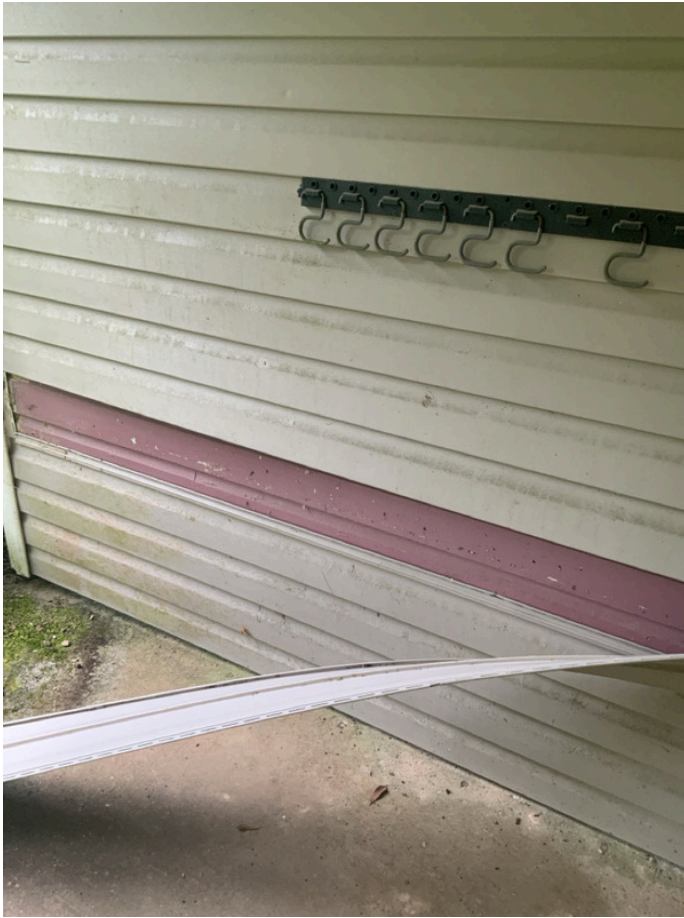
XRF Shot #	28
Area (XRF)	Exterior
Room (XRF)	
Building Feature (XRF)	Wall
Component (XRF)	Wall
Substrate (XRF)	Wood
Location (XRF)	D
Paint Color (XRF)	Pink
Condition (XRF)	Impact Friction
XRF Result: (mg/cm <sup>2</sup> )	1.2
Lead Present:	Yes

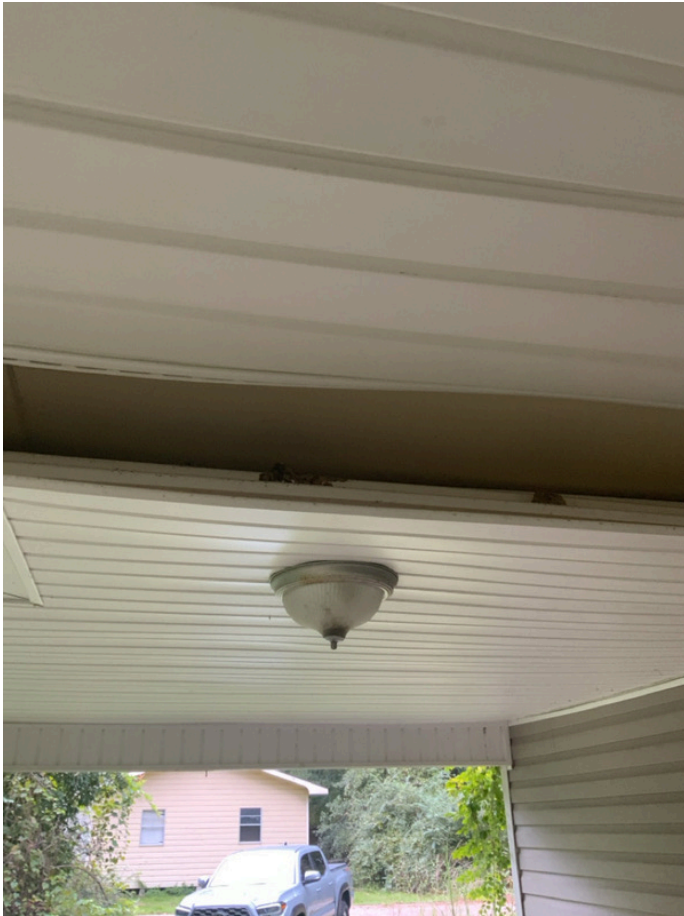
XRF Shot #	33
Area (XRF)	Exterior
Room (XRF)	Carport
Building Feature (XRF)	Wall
Component (XRF)	Ceiling
Substrate (XRF)	Wood
Location (XRF)	
Paint Color (XRF)	White
Condition (XRF)	Impact Friction
XRF Result: (mg/cm <sup>2</sup> )	1.2
Lead Present:	Yes

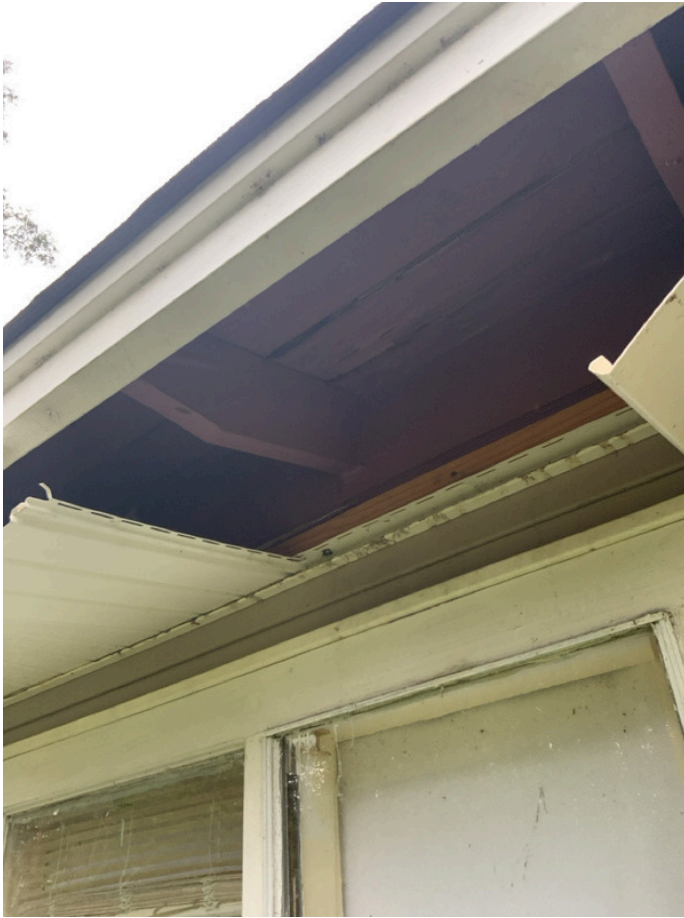
XRF Shot #	35
Area (XRF)	Exterior
Room (XRF)	
Building Feature (XRF)	Roof
Component (XRF)	Soffit
Substrate (XRF)	Wood
Location (XRF)	A
Paint Color (XRF)	Pink
Condition (XRF)	Cracking
XRF Result: (mg/cm <sup>2</sup> )	1.5
Lead Present:	Yes
