DAMAGE DIAGRAMS

Louisiana Office of Risk Management
 #16 Dormitory
 5445 Point Clair Road
 Carville, LA 70721

Claim No.: 4A2310TKFSM-0001

November 17, 2023

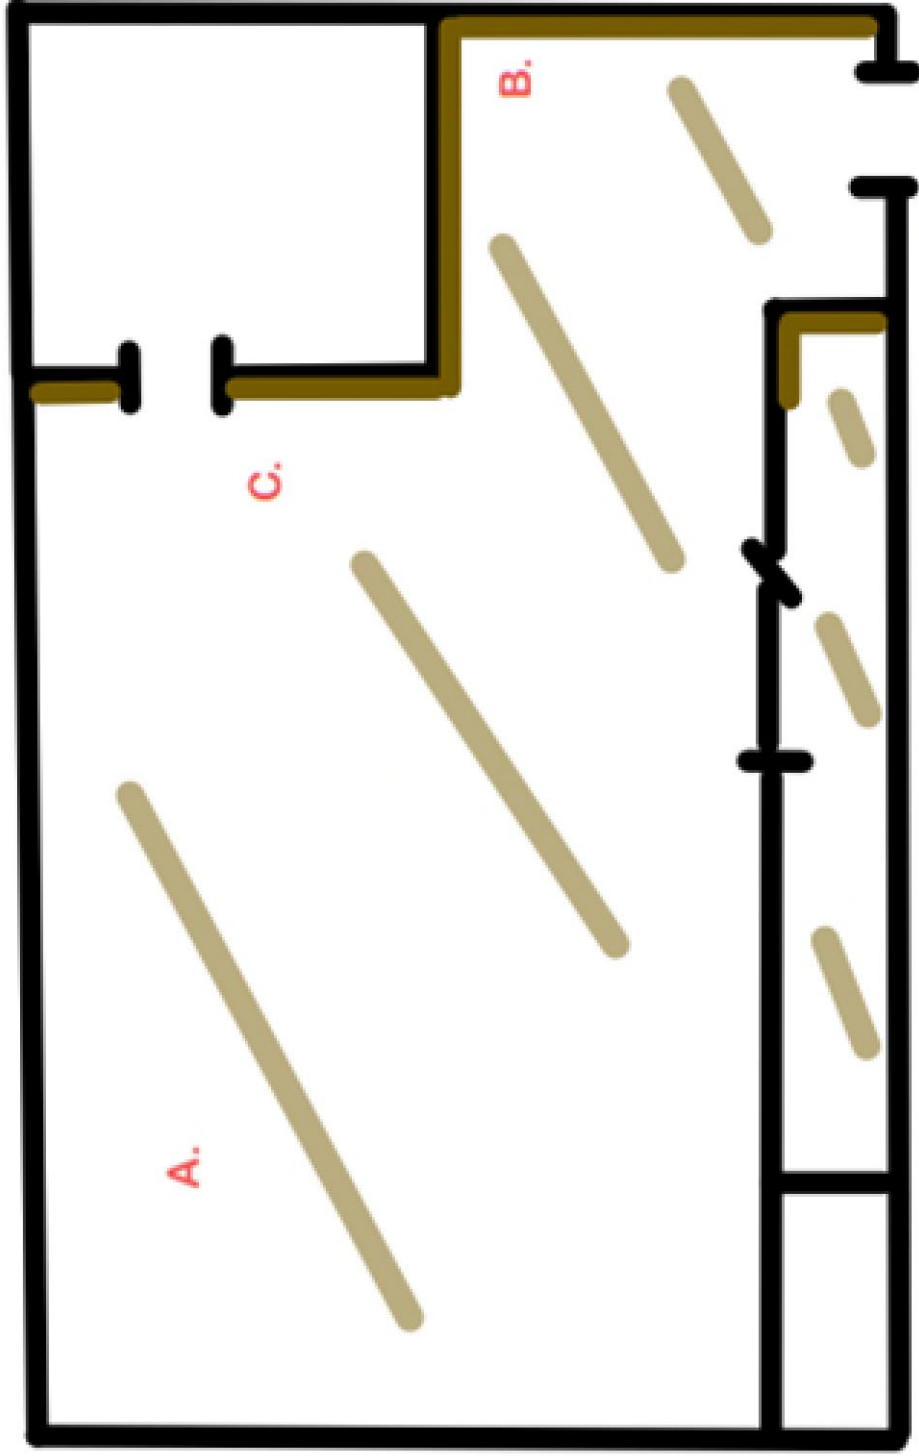
224

- A. Laminate flooring removed
- B. FRP removed
- C. Baseboards removed

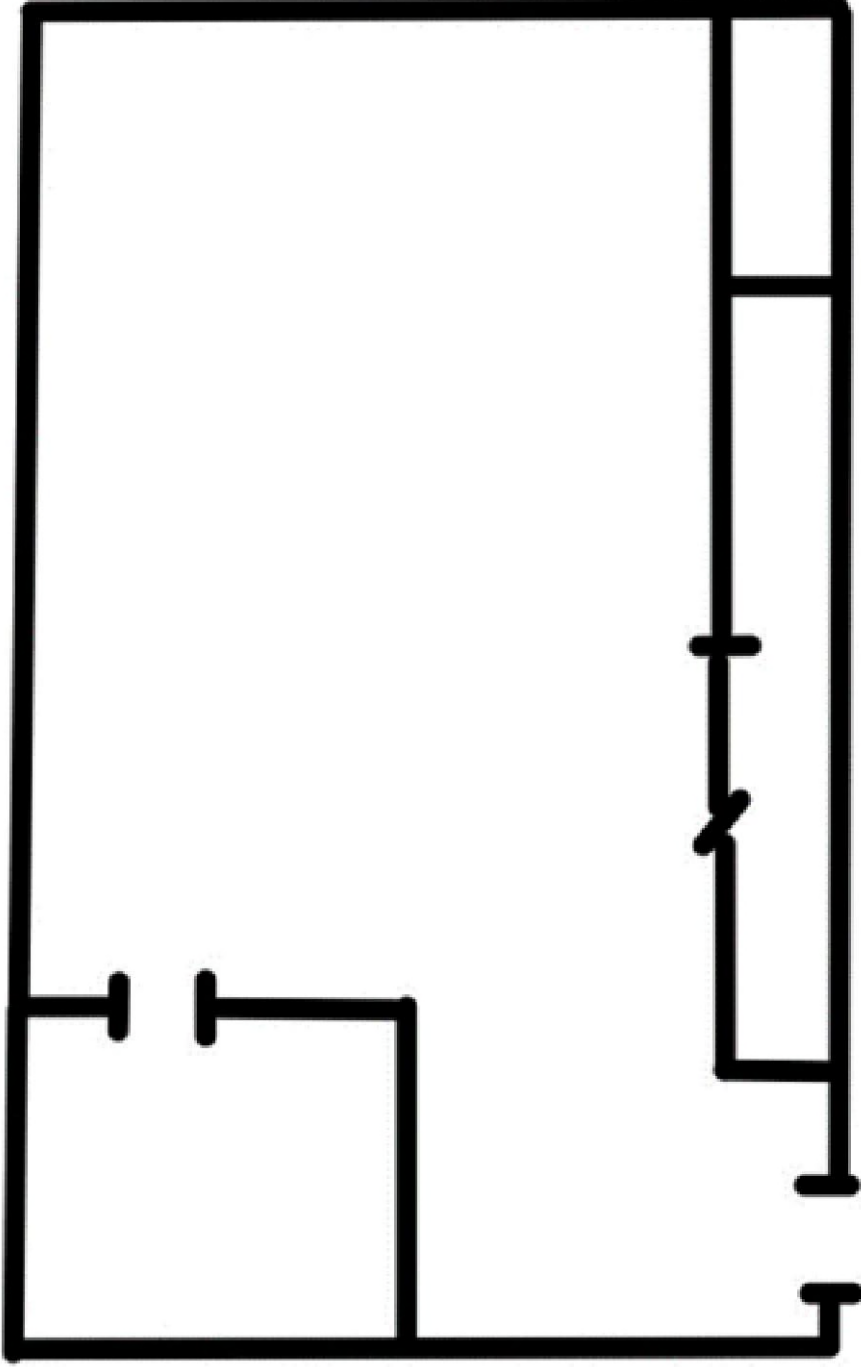
No damages observed at time of EFI investigation

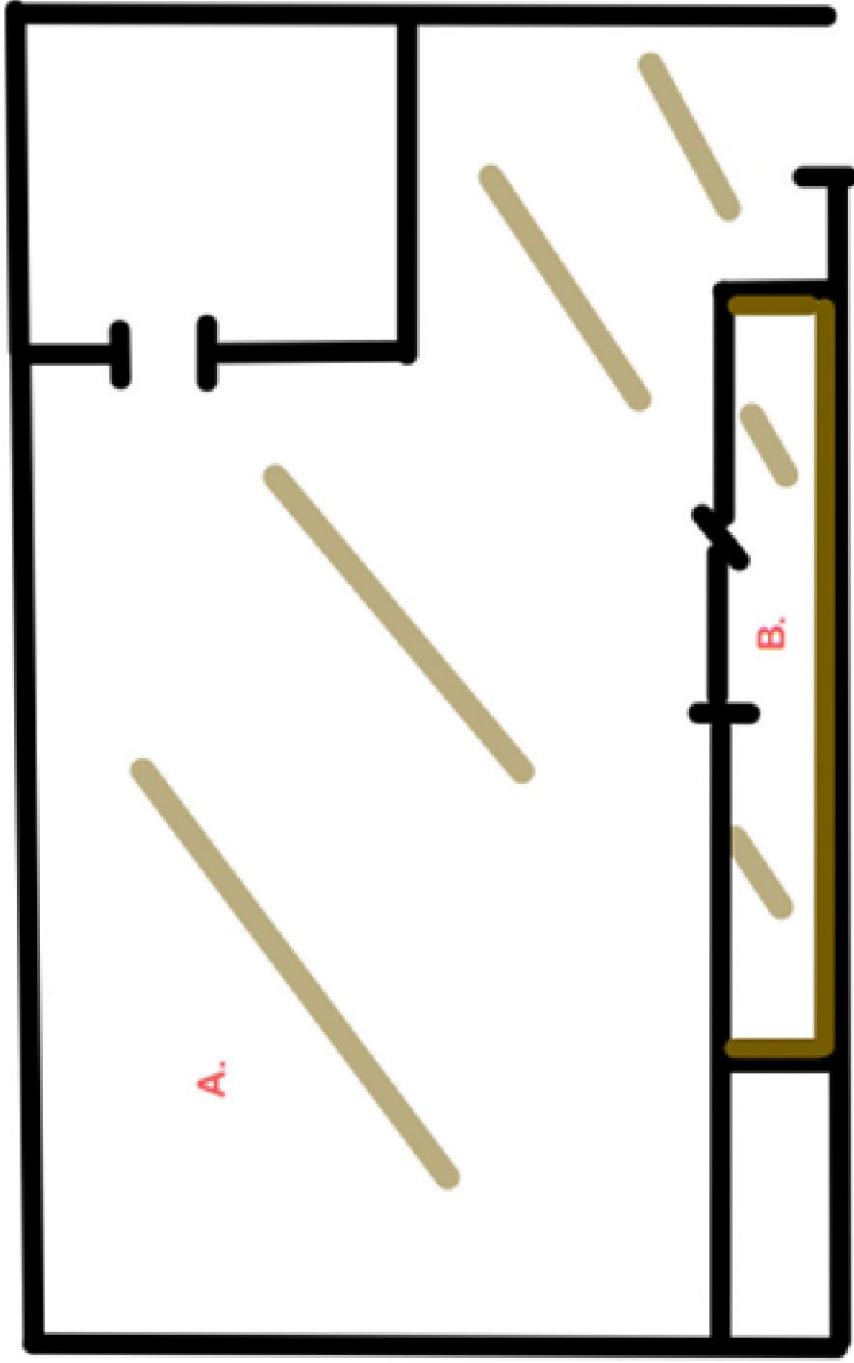
216

- A. Laminate flooring removed
- B. Baseboards removed

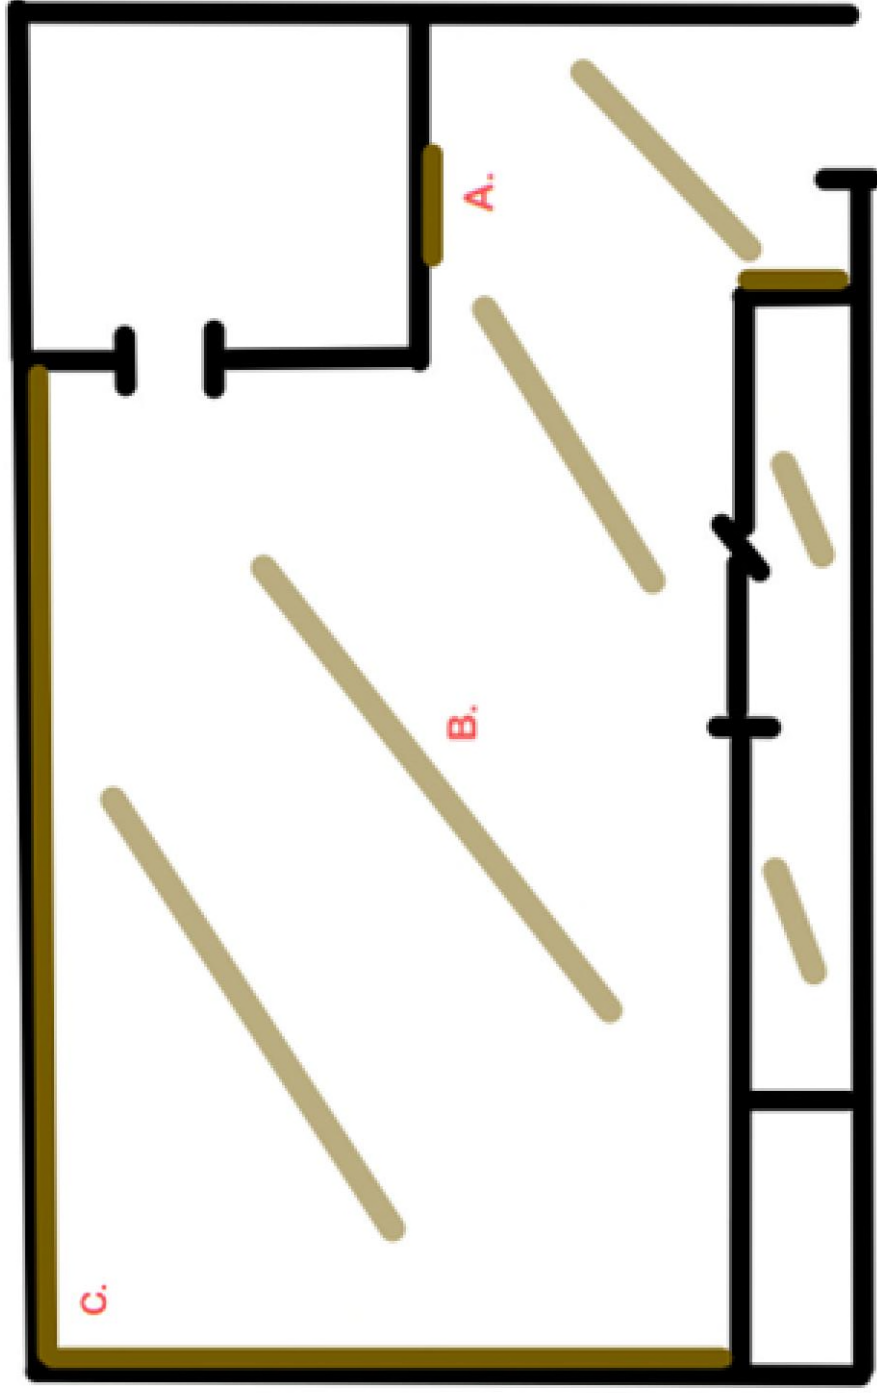
116

- A. Hole removed in wall
- B. Laminate flooring removed
- C. Baseboards removed

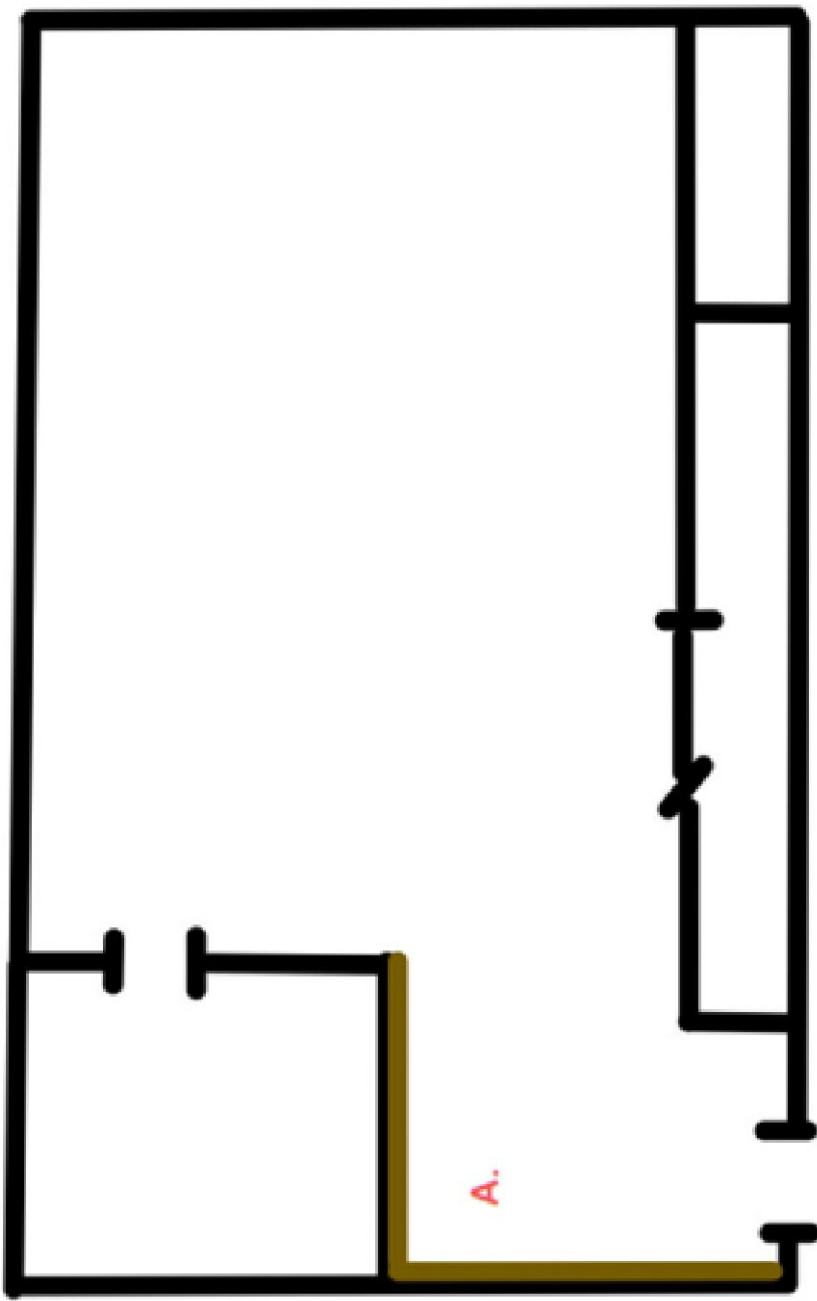
110

A. Baseboards removed
