**ADDENDUM NO. 2**

Your reference is directed to **SB#7678 NSU Prudhomme Hall Demolition** which is scheduled for bid openings at 2:00PM Thursday, October 29th, at Northwestern State University, Natchitoches, Louisiana.

# ASBESTOS INSPECTION REPORT

NSU Prudhomme Hall  
Natchitoches, LA 71457  
*Asbestos-Containing Materials Detected*

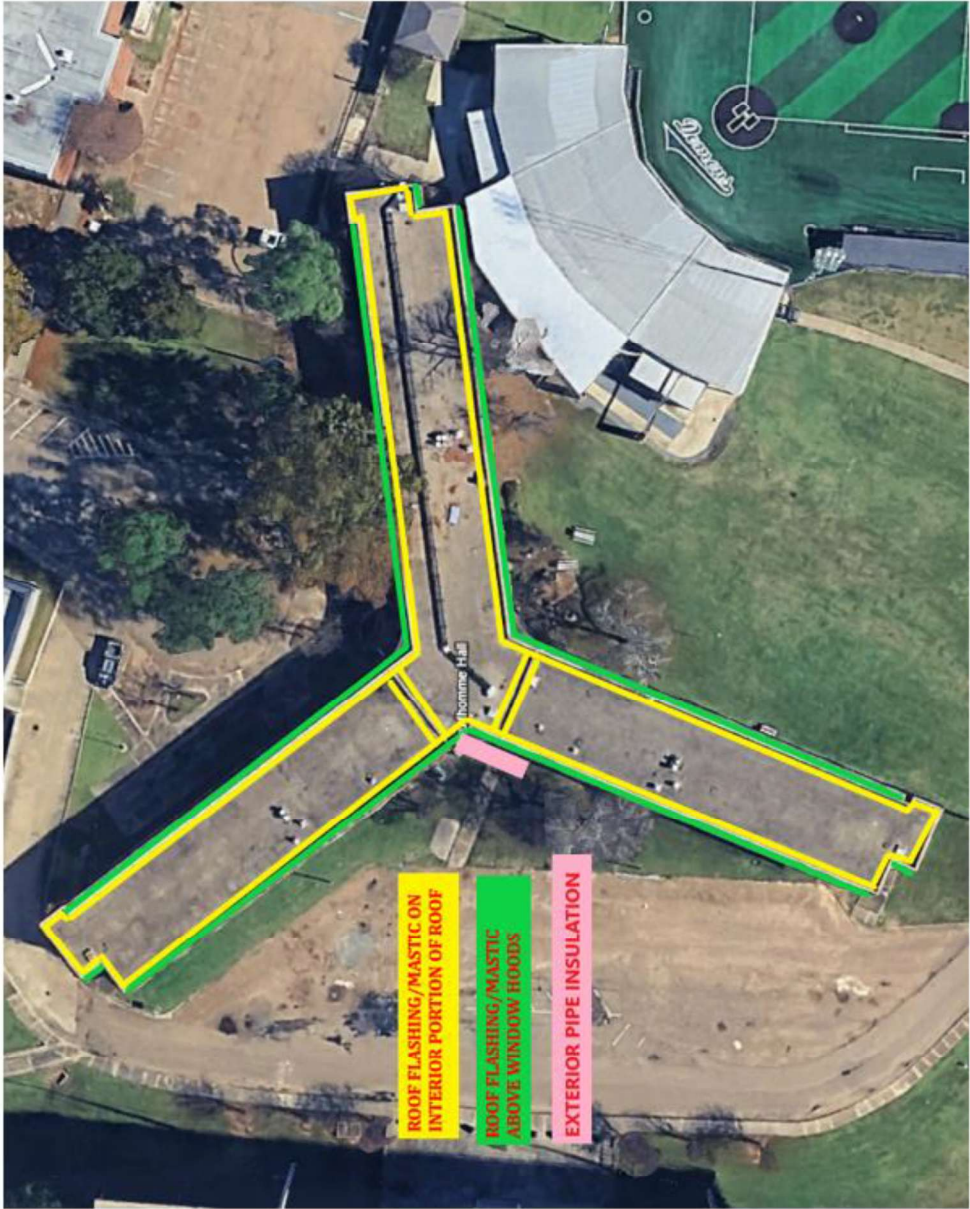
Figure  
Number  
PH-3

PRUDHOMME HALL  
ACM HOMOGENEOUS AREAS

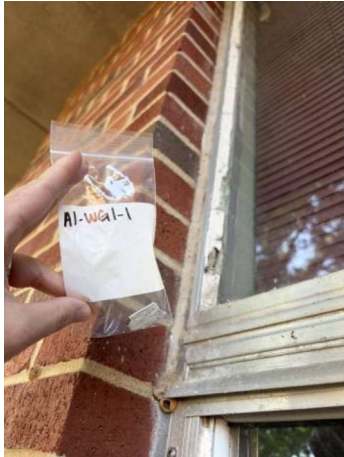
Window glazing was re-analyzed using point count method for better accuracy. The point count result shows 1% Chrysotile. Therefore, it is not considered an asbestos-containing material (defined as >1% asbestos by weight).

WINDOW GLAZING  
(A1-WG1-1, B1-WG1-2, C1-WG1-3)

| Client ID | Lab ID | Layer | Sample Description | Asbestos % |
|---|---|---|---|---|
| A1-WG1-1 | 4448667 | | White/gray glazing | Chrysotile 2% |

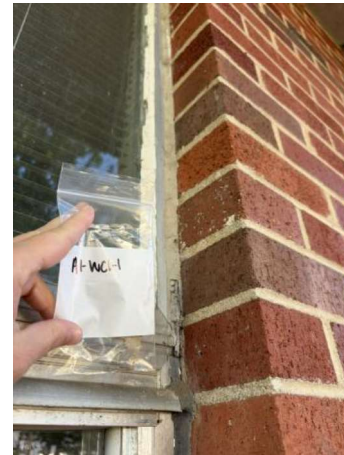
TAN WINDOW CAULK (A1-WC1-1)

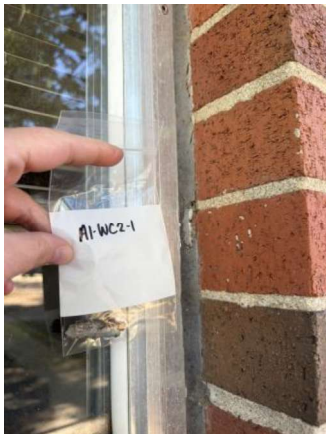
GREY WINDOW CAULK  
(A1-WC2-1, B1-WC2-1, C1-WC2-3)

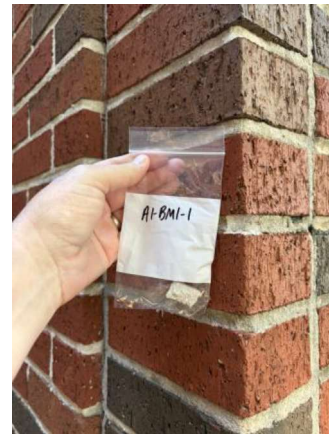
BRICK MORTAR  
(A1-BM1-1, C1-BM1-2, B1-BM1-3)

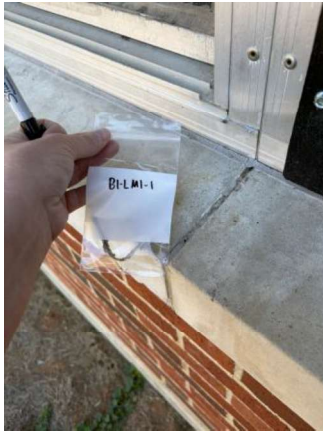
WINDOW LEDGE MORTAR (B1-LM1-1)

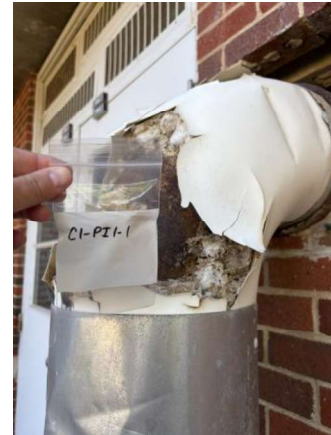
| Sample Number | Sample Description | Approx. Sq./Linear Footage | Laboratory Results | Category |
|---|---|---|---|---|
| C1-PI1-1,<br>C1-PI1-2 | EXTERIOR PIPE INSULATION COATING/MASTIC | 20 LF | 5%<br>CHRYSTILE | RACM |

EXTERIOR PIPE INSULATION (C1-PI1-1)

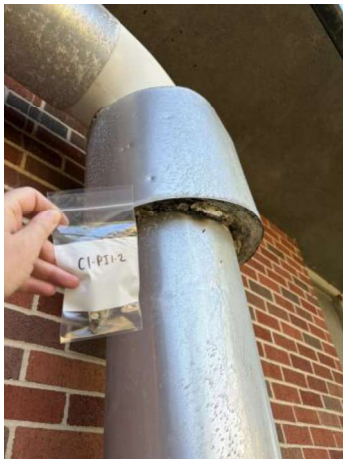
EXTERIOR PIPE INSULATION (C1-PI1-2)

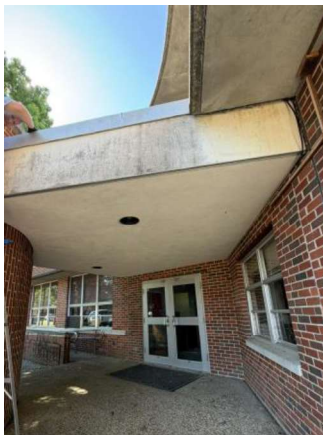
STUCCO COATING FRONT ENTRANCE  
(B1-SC1-1, B1-SC1-2, B1-SC1-3)

| Client ID | Lab ID | Layer | Sample Description | Asbestos % |
|---|---|---|---|---|
| B1-SC1-1 | 4448664 | | White stucco coating | None Detected |

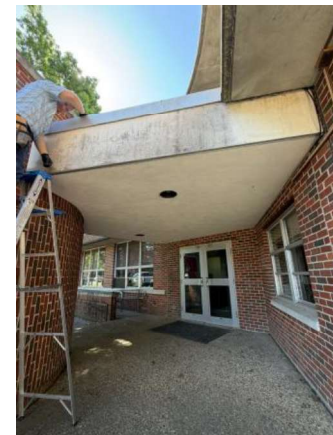
FLAT ROOF FRONT ENTRANCE  
(B1-FR1-1, B1-FR1-2)

| Client ID | Lab ID | Layer | Sample Description | Asbestos % |
|---|---|---|---|---|
| B1-FR1-1 | 4448662 | | Black/gray roofing | None Detected |

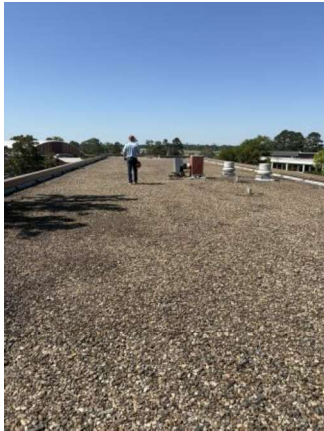
BUILT UP FLAT ROOF MAIN STRUCTURE  
(CR-FR1-1, AR-FR1-2, BR-FR1-3)

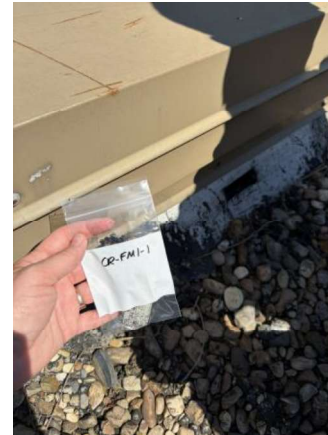
| Sample Number | Sample Description | Approx. Sq./Linear Footage | Laboratory Results | Category |
|---|---|---|---|---|
| BR-FM1-3 | ROOF FLASHING/MASTIC ON INTERIOR OF ROOF | 1,356 LF | 5%<br>CHRYSTILE | CAT 1 NF |

INTERIOR ROOF FLASHING MASTIC  
(CR-FM1-1, AR-FM1-2, BR-FM1-3)

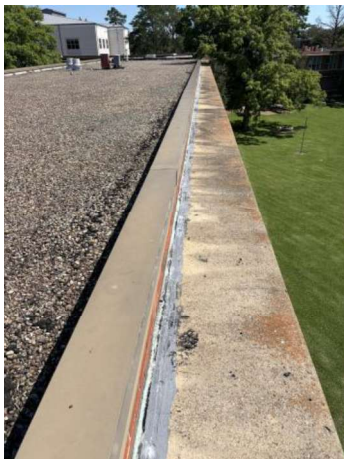
| Sample Number | Sample Description | Approx. Sq./Linear Footage | Laboratory Results | Category |
|---|---|---|---|---|
| CR-FM2-1,<br>BR-FM2-2 | ROOF FLASHING/MASTIC ABOVE WINDOW HOODS (2 LEVELS) | 2,115 LF | 5%<br>CHRYSTILE | CAT 1 NF |

EXTERIOR FLASHING MASTIC  
(CR-FM2-1, BR-FM2-2)

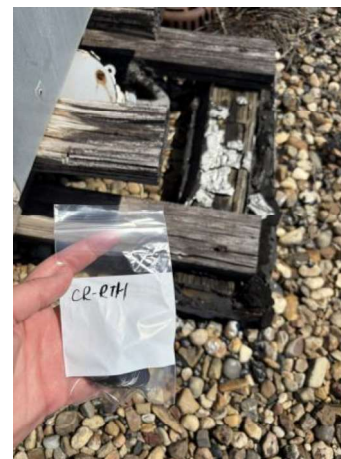
ROOFING TAR  
(CR-RT1-1, BR-RT1-2)

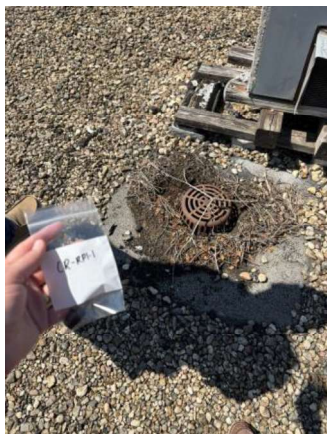
ROOF PATCH (CR-RP1-1)

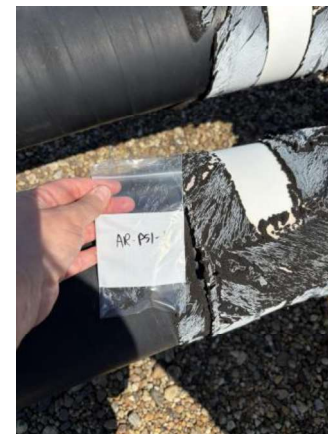
BLACK PIPE SEALANT (AR-PS1-1)

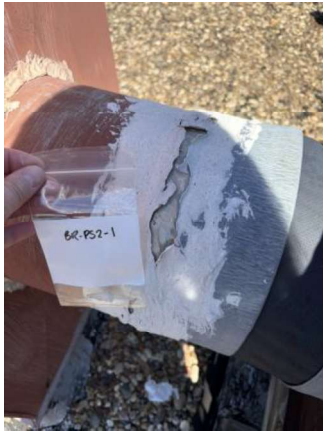
WHITE PIP SEALANT (BR-PS2-1)

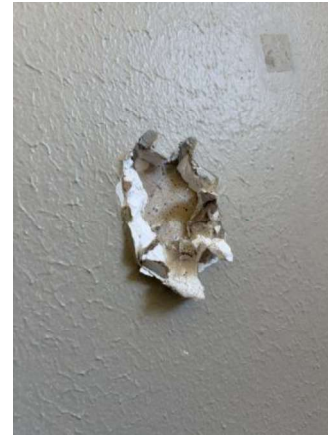
DRYWALL (2C-DW1-1, 2B-DW1-2, 1C-DW1-3, 2C-DW1-4, 2C-DW1-5, 1A-DW1-6, 1B-DW1-7)

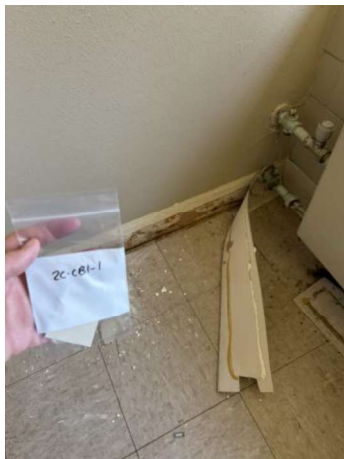
TAN COVE BASE WITH MASTIC (2C-CB1-1, 2B-CB1-2)

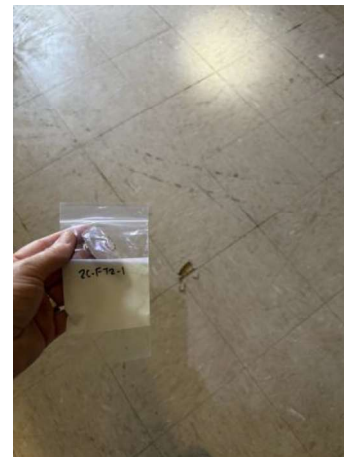
BEIGE FLOOR TILE (2C-FT2-1, 2A-FT2-2)

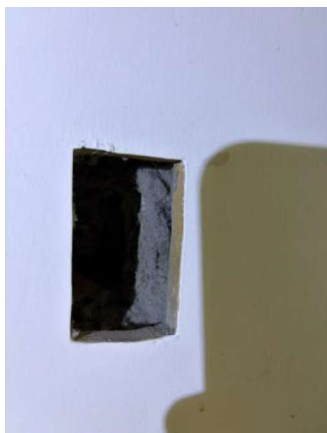
GREY WALL INSULATION (2C-WI1-1)

| Client ID | Lab | Lab | NON-ASBESTOS COMPONENTS | | | | ASBESTOS |
|---|---|---|---|---|---|---|---|
| 2C-WI1-1<br>4448587 | Wall Insulation | Heterogeneous<br>Gray<br>Fibrous<br>Loosely Bound | 100% | Cellulose | | | None Detected |

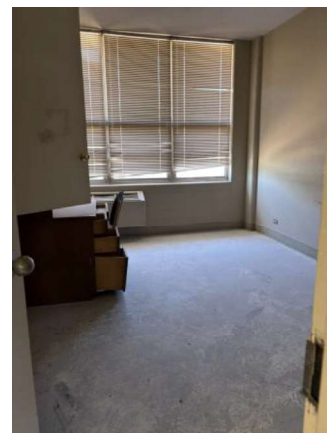
GREY FLOOR TILE  
(2C-FT3-1, 1C-FT3-2)

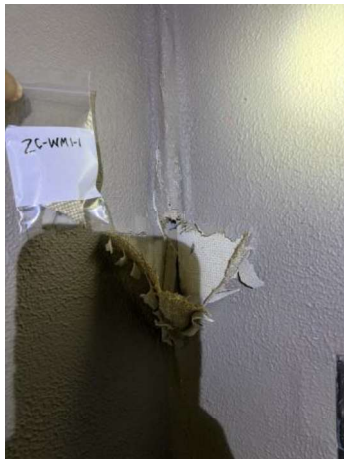
PAPER-LIKE WALL MATERIAL (2C-WM1-1, 1A-WM1-2, 1A-WM1-3, 1A-WM1-4, 1A-WM1-5)

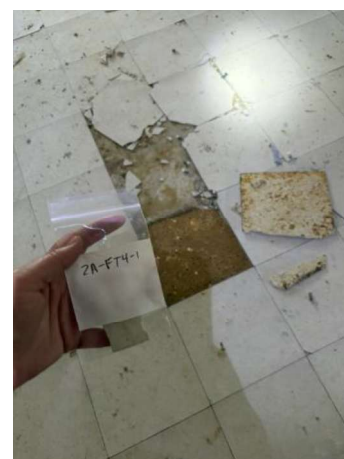
WHITE FLOOR TILE (2A-FT4-1, 1B-FT4-2)

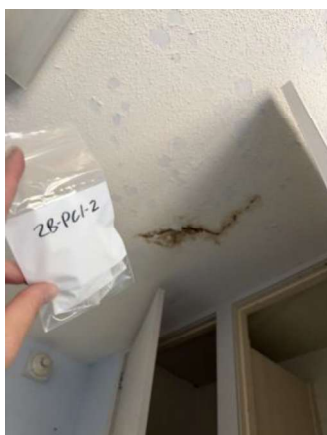
POPCORN CEILING TEXTURE (A1-PC1-1, 2B-PC1-2, 1C-PC1-3, 2C-PC1-4, 2A-PC1-5, B1-PC1-6, C1-PC1-7)

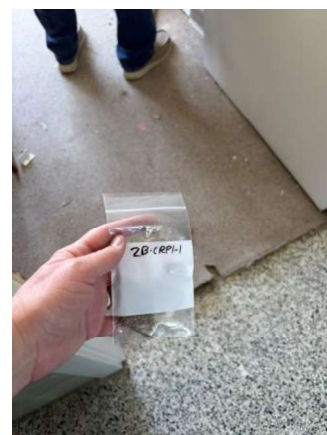
BROWN CARPET (2B-CRP1-1)

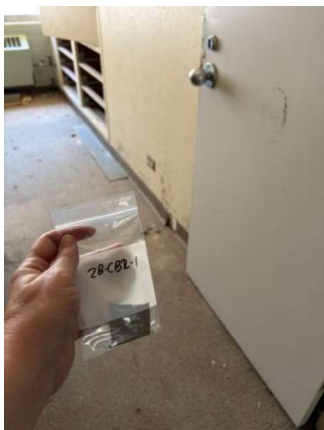
BROWN COVE BASE (2B-CB2-1)

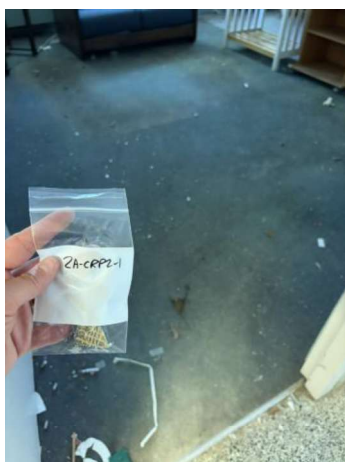
BLUE CARPET (2A-CRP2-1)

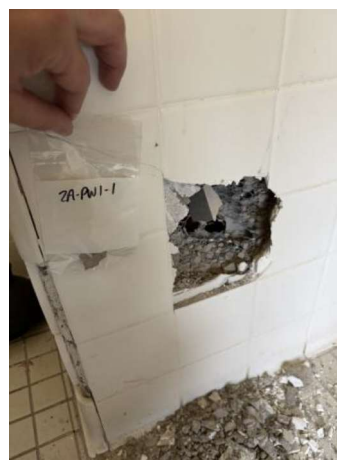
COCONRETE WALL (2A-PW1-1)

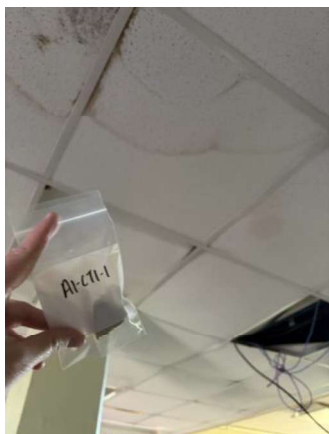
2' X 2' CEILING TILE (A1-CT1-1, 2C-CT1-2)

| Client ID | Lab | Lab | NON-ASBESTOS COMPONENTS | | | | ASBESTOS |
|---|---|---|---|---|---|---|---|
| A1-CT1-1<br>4448588 | Ceiling Tile | Heterogeneous<br>White/tan<br>Fibrous<br>Loosely Bound | 60%<br>20% | Cellulose<br>Glass | 15%<br>5% | Perlite<br>Paint | None Detected |
| 2C-CT1-2<br>4448589 | Ceiling Tile | Heterogeneous<br>White/tan<br>Fibrous<br>Loosely Bound | 60%<br>20% | Cellulose<br>Glass | 15%<br>5% | Perlite<br>Paint | None Detected |

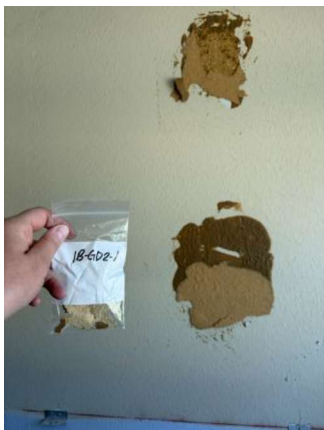
GLUE PATCH ON WALL (1B-GD2-1)

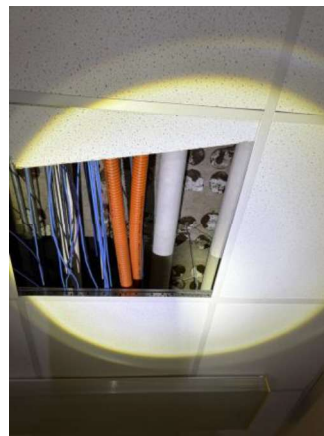
CEILING GLUE DOTS (A1-GD1-1, A1-GD1-2)

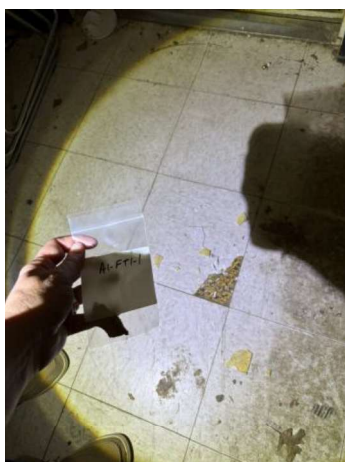
TAN FLOOR TILE (A1-FT1-1, A1-FT1-2)

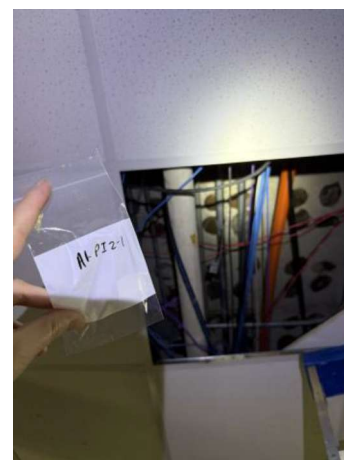
Per Brady Henderson, prior records indicate that all interior TSI was abated from the facility in July of 2010 by Insulation Technologies. For this reason, only one interior pipe insulation sample was collected.

INTERIOR PIPE INSULATION/WRAP (A1-PI2-1)
