**CITY OF BATON ROUGE  
PARISH OF EAST BATON ROUGE  
ON BEHALF OF THE  
GREATER BATON ROUGE METROPOLITAN AIRPORT DISTRICT**

**ADDENDUM NO. 2**

**DEMOLITION OF MULTIPLE STRUCTURES FOR  
RUNWAY 13/31 SAFETY AREA AND RPZ RUNWAY IMPROVEMENTS  
LA HWY. 67 / PLANK RD. PHASE I DEMOLITION**

Photographic Documentation

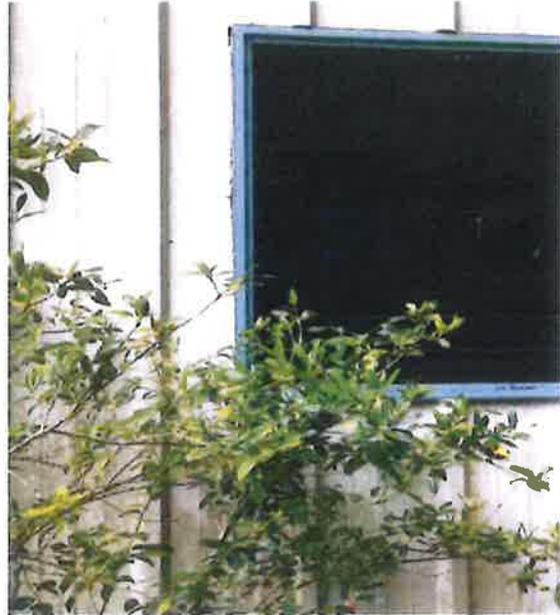
Photo 2  
Window Caulking  
Samples 1, 2, 3  
HA#1

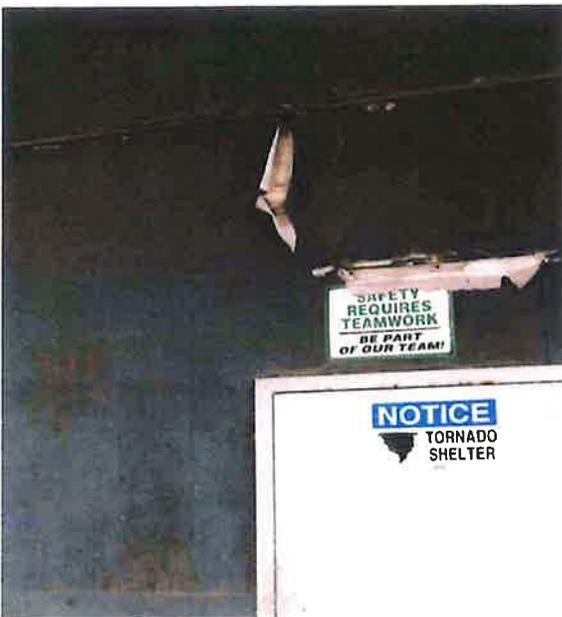
Photo 3  
Sheetrock and Joint Compound

Samples 4-9  
HA#3

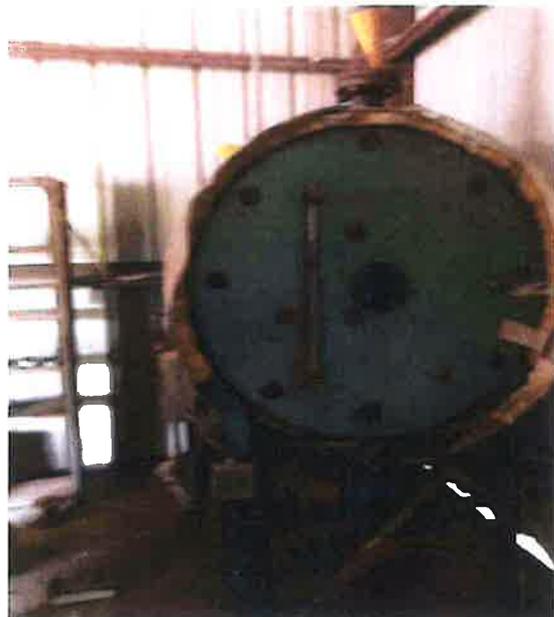
Photo 4  
TSI

Samples 10, 11, 12  
HA#4

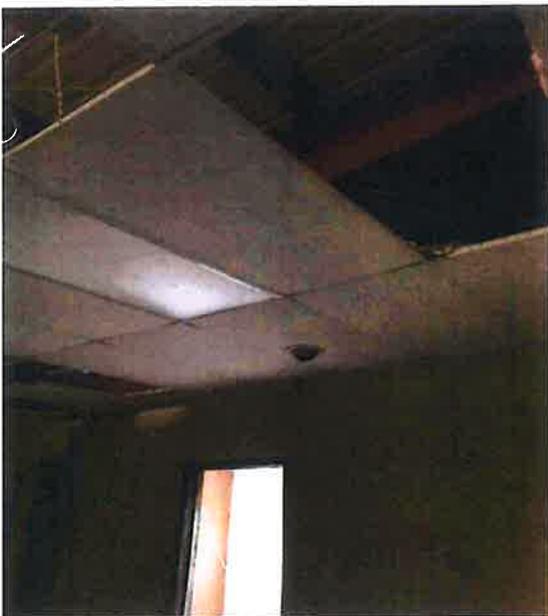
Photo 7  
2' x 4' Ceiling Tile

Samples 19, 20, 21  
HA#7

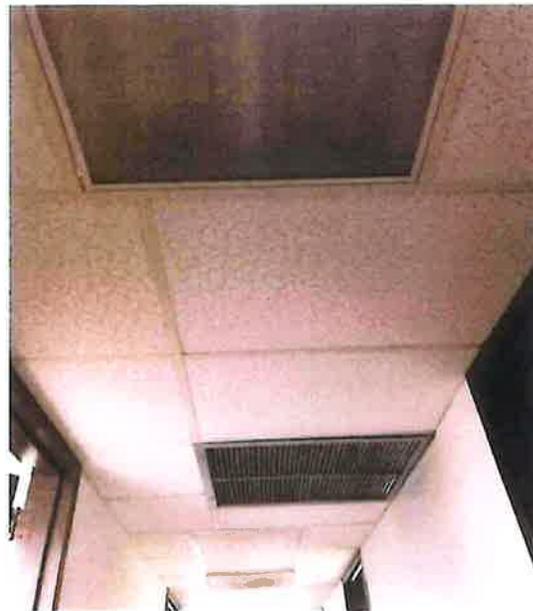
Photo 8  
2' x 2' Ceiling Tile

Samples 22, 23, 24  
HA#8

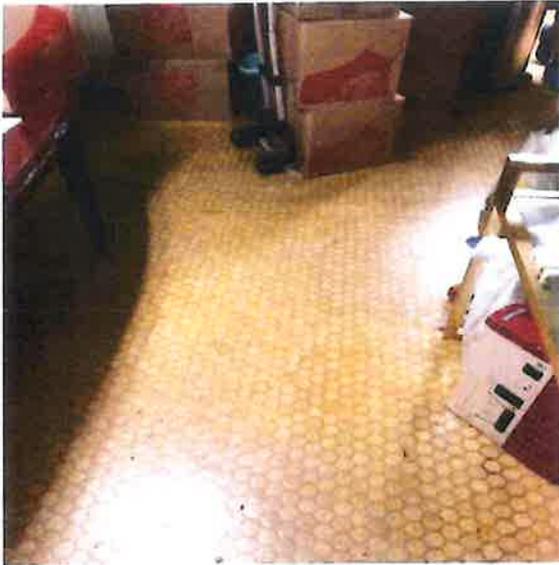
Photo 1  
Rolled Flooring

Samples 1, 2, 3  
HA#1

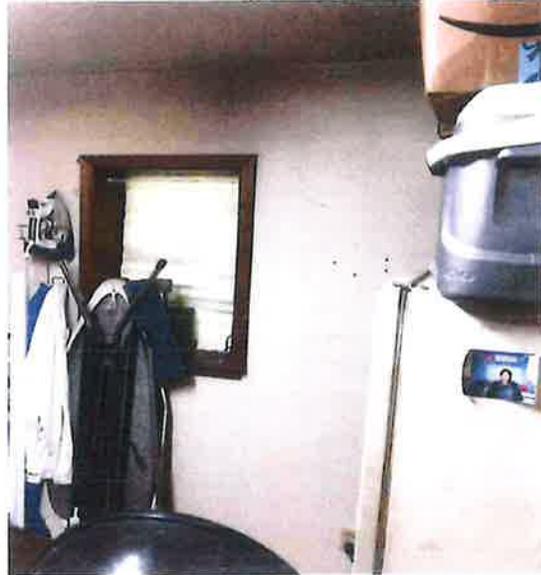
Photo 2  
Sheetrock and Joint Compound

Samples 4, 5, 6  
HA#2

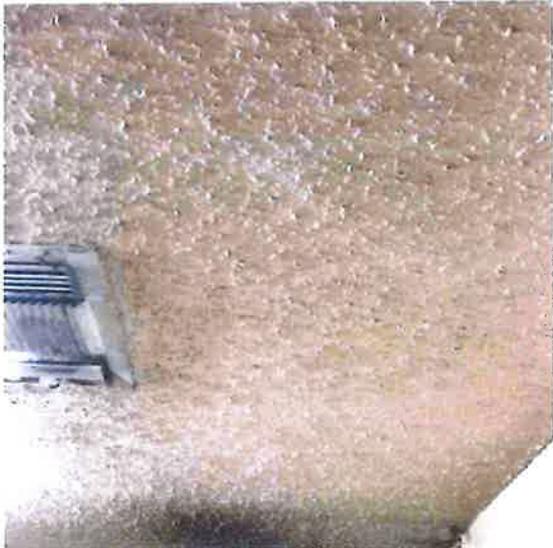
Photo 3  
Popcorn Ceiling

Samples 7, 8, 9  
HA#3

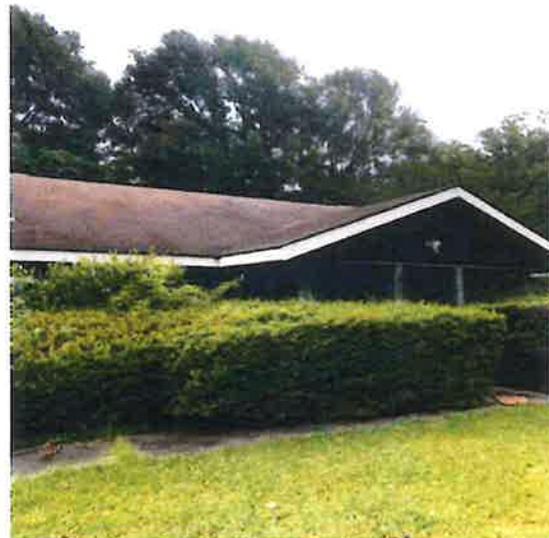
Photo 4  
Roofing

Samples 10, 11, 12  
HA#4

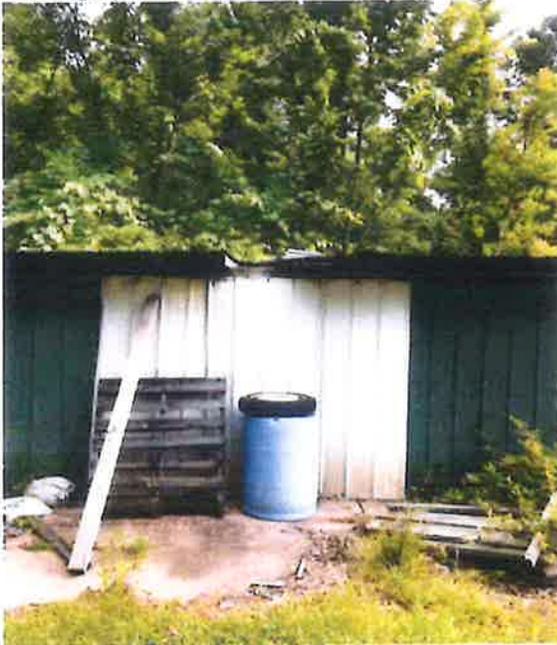
Photo 5  
Pegboard

Samples 11, 12, 13  
HA#5

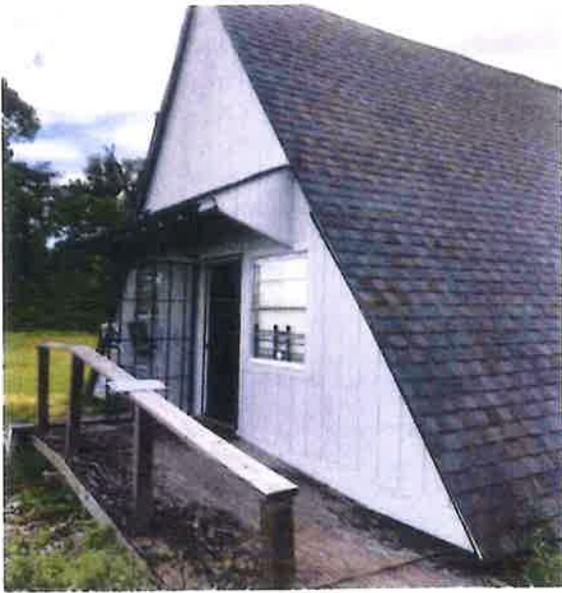
Photo 1  
Roofing

Samples 1, 2, 3  
HA#1

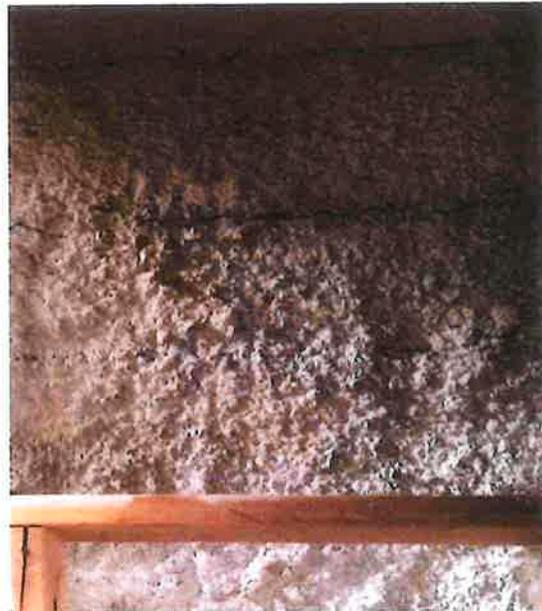
Photo 2  
Spray on Insulation

Samples 4, 5, 6  
HA#2

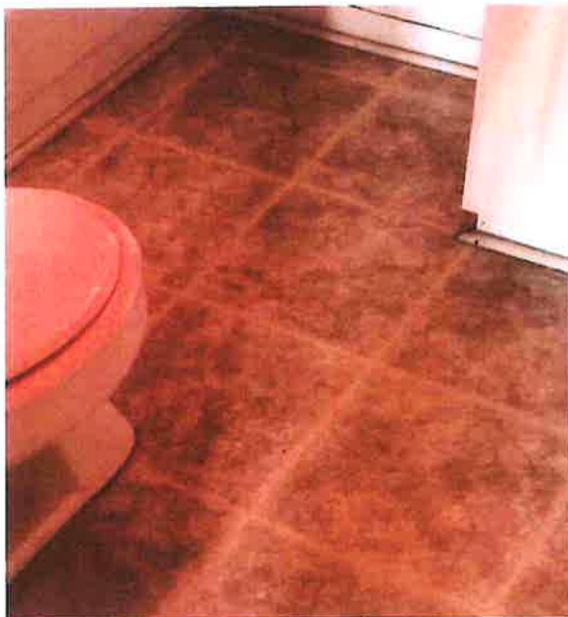
Photo 3  
Linoleum Flooring

Samples 7, 8, 9  
HA#3

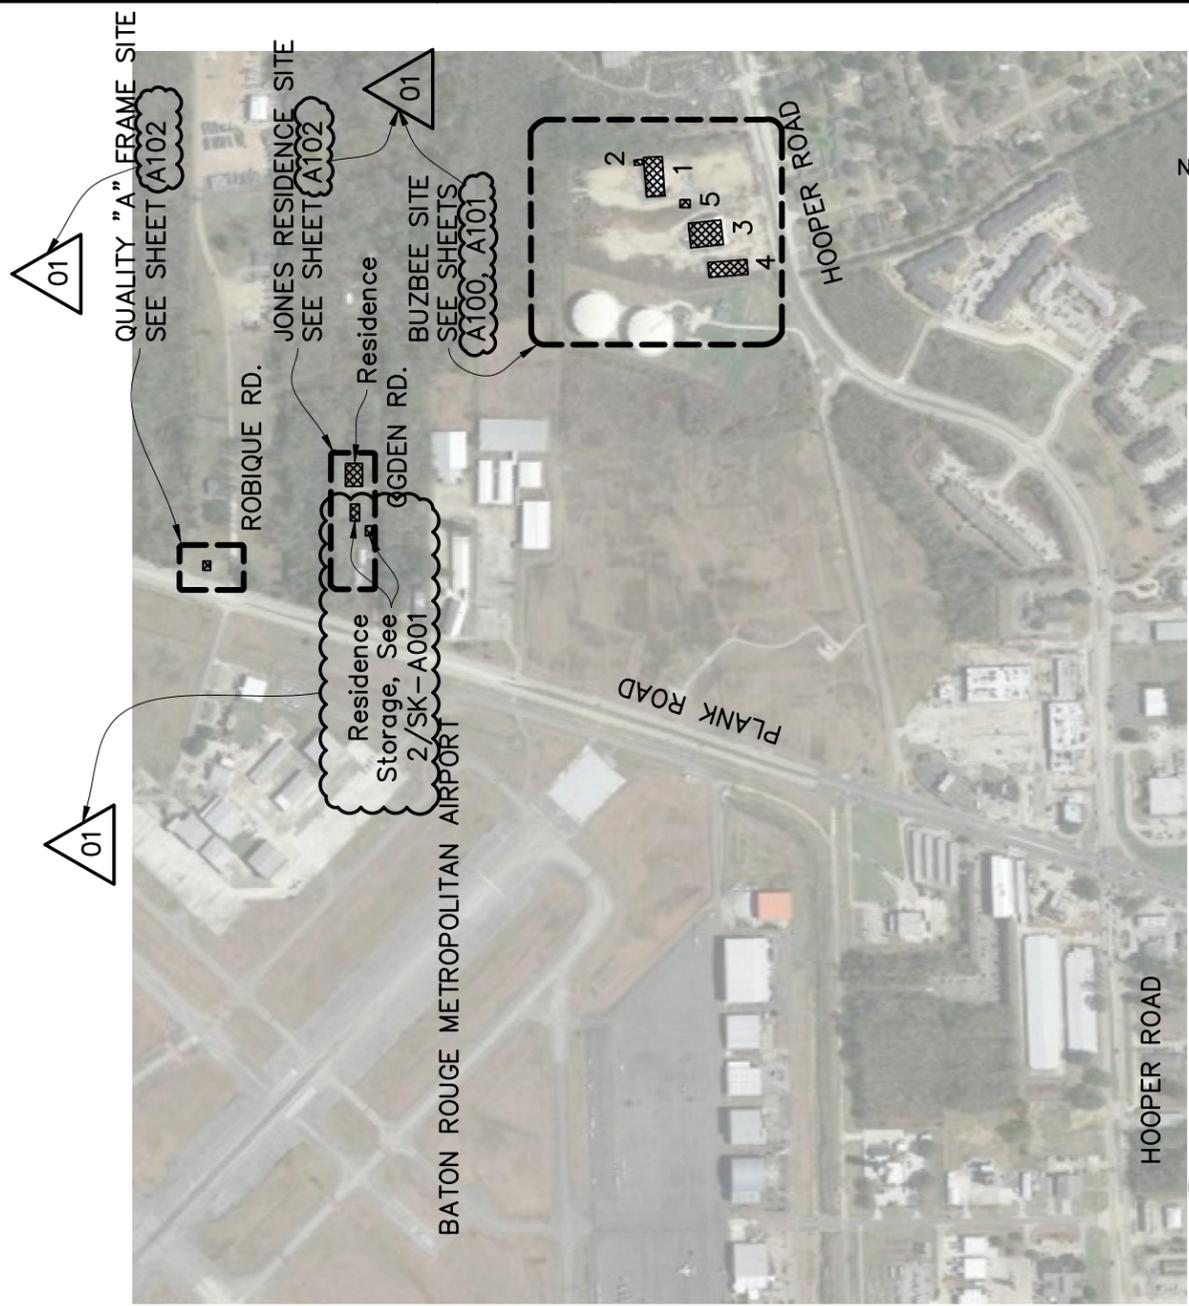
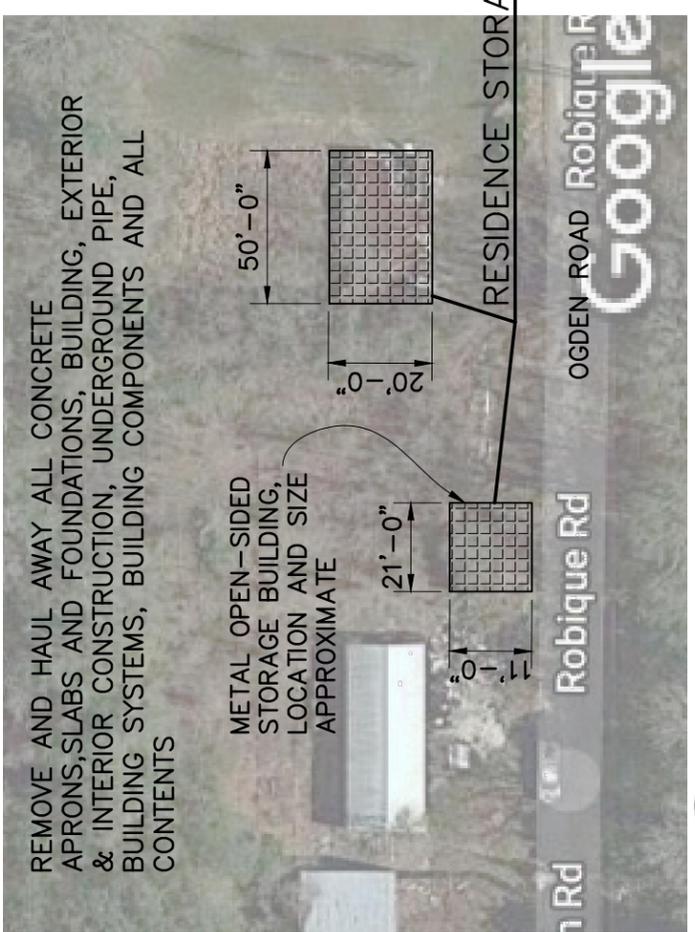
sheet no. **SK-A001**  
 of 6 sheets

Drawings, Sheet No. A001, Overall Site Plan Notes, Detail No. 1: Delete this detail in its entirety and Replace with the Sketch numbered AD2-66. The two storage sheds originally shown are not part of the Jones Residence property and shall remain. The Jones Residence storage sheds to be removed are now indicated on the enclosed Sketch numbered AD2-66.

△ 01 EDITED SHEET NUMBERS FOR ACCURACY, UPDATED CORRECT LOCATION OF RESIDENCE STORAGE BUILDINGS TO BE DEMOLISHED
