DEMOLITION OF DENTAL CLINIC

Addendum 04

Asbestos, Lead-Based Paint & Universal Regulated Waste Survey Report

Dental Clinic and Pharmacy Buildings

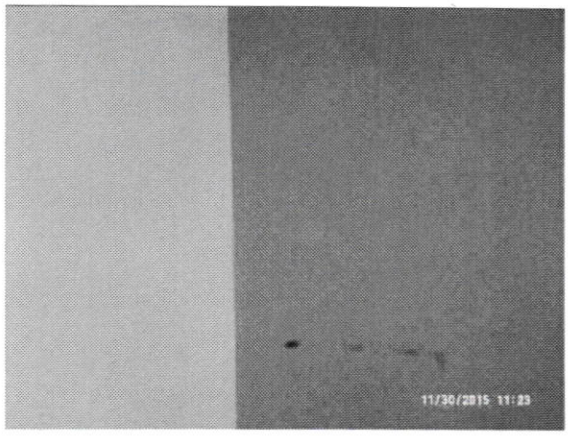
Photo #3 View of HA No. 02 – drywall walls with associated joint compound located in the dental clinic (ND)

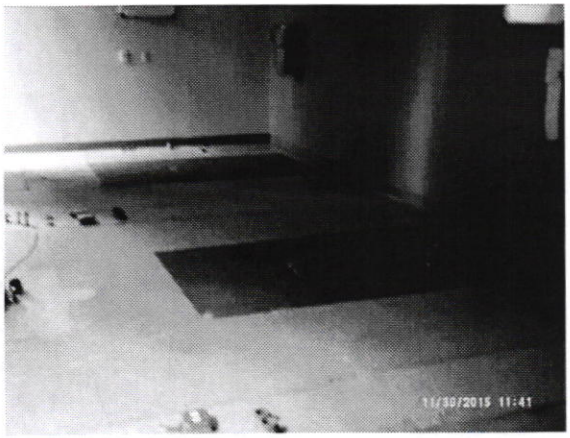
Photo #7 View of HA No. 06 – 12"x12" brown floor tile with yellow glue located in the dental clinic (ND)

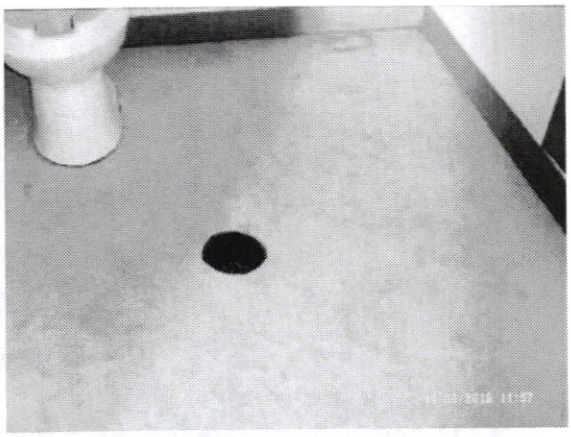
Photo #9 View of HA No. 08 – laminate flooring located in the restrooms of the dental clinic (ND)

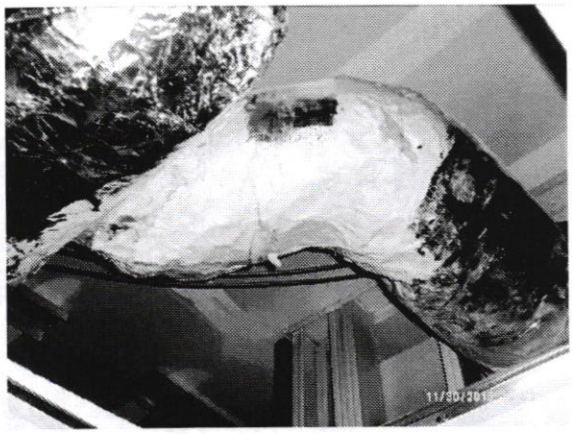
Photo #10 View of HA No. 09 – HVAC duct wrap with associated mastic located above the ceiling deck in the dental clinic (ND)

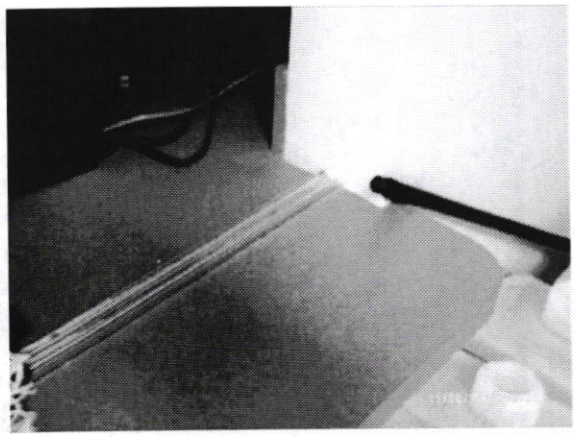
Photo #12 View of HA No. 11 – laminate countertops in the dental clinic (ND)

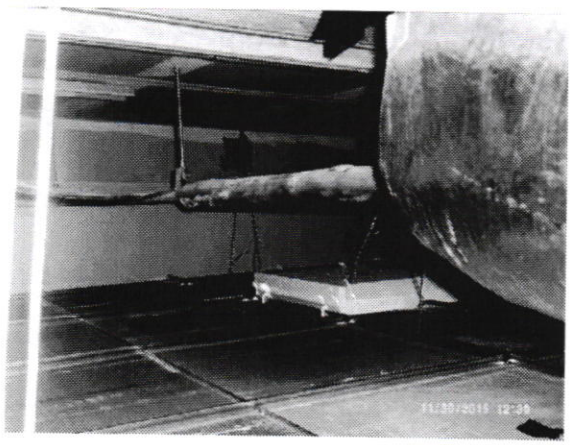
Photo #13 View of HA No. 12 – black insulation on the water pipes located above the ceiling deck of the dental clinic (ND)

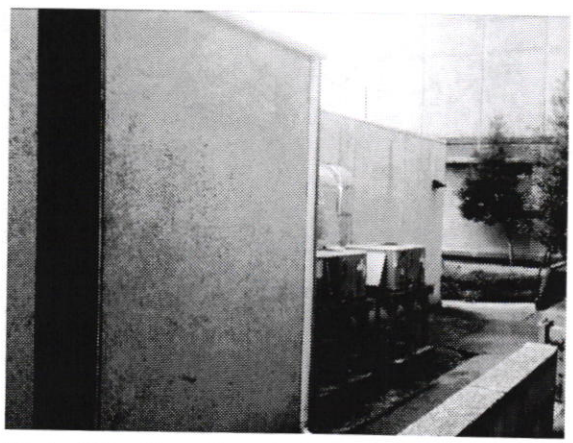
Photo #15 View of exterior of pharmacy building

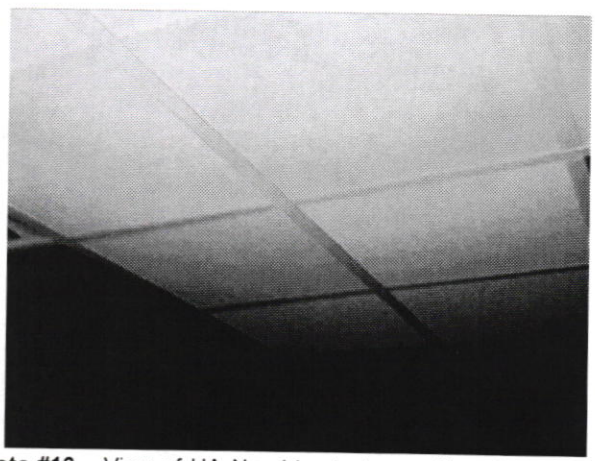
Photo #16 View of HA No. 14 – texture ceiling tile located in the IV lab of the pharmacy building (ND)

Photo #17 View of HA No. 15 – 2'x2' worm/pinhole ceiling tile located in the pharmacy building (ND)

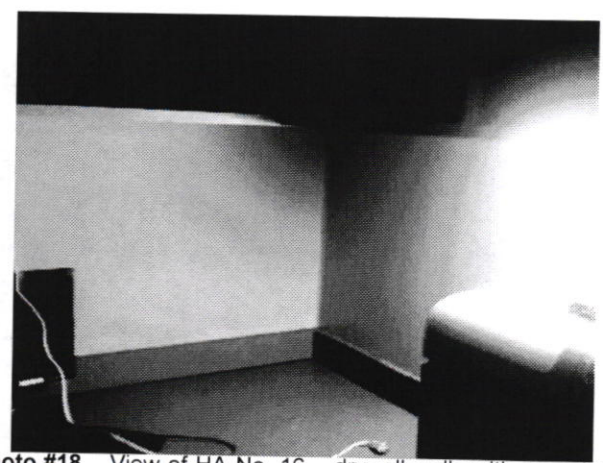
Photo #18 View of HA No. 16 – drywall walls with associated joint compound located in the pharmacy building (ND)

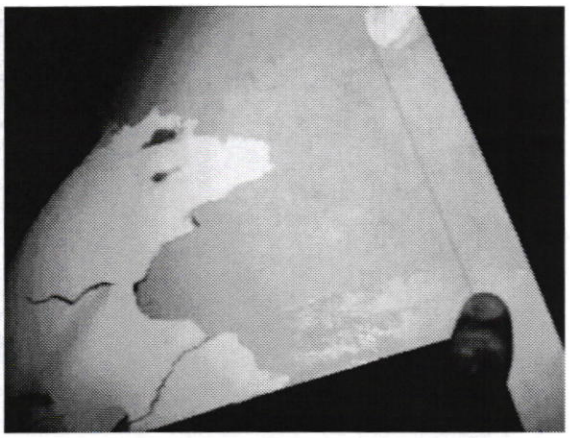
Photo #19 View of HA No. 17 – Clear mastic behind the Fiber Reinforced plastic wainscot located in the pharmacy building (ND)

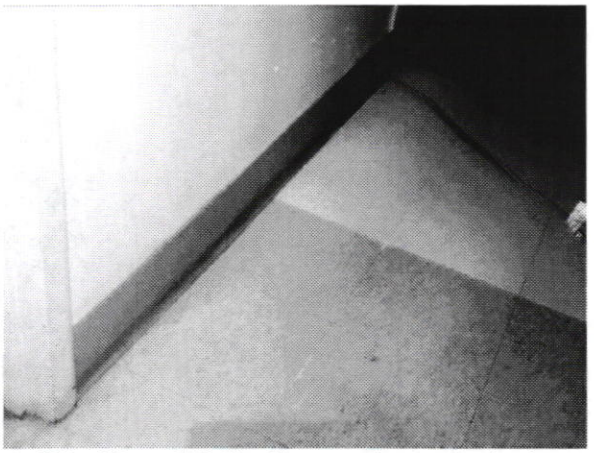
Photo #20 View of HA No. 18 – cove base adhesive located in the pharmacy building (ND)

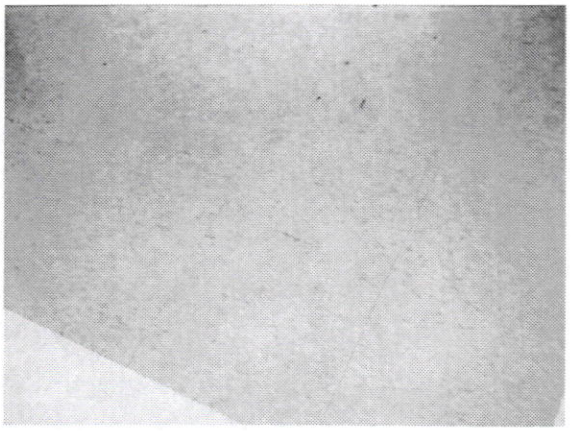
Photo #21 View of HA No. 19 – 12"x12" tan floor tile with yellow glue located in the pharmacy building (ND)

Photo #22 View of HA No. 20 – 12"x12" off-white floor tile with yellow glue located in the pharmacy building (ND)

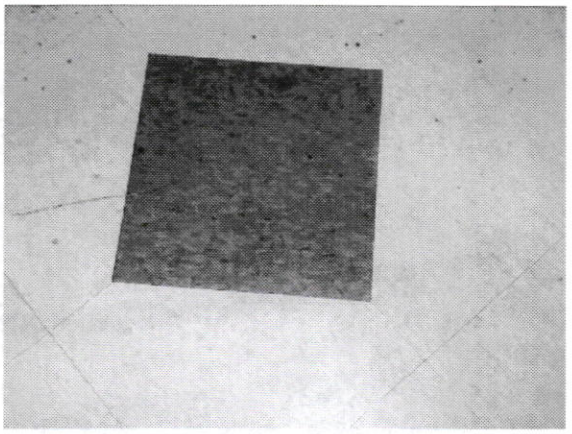
Photo #23 View of HA No. 21 – 12"x12" blue floor tile with yellow glue located in the pharmacy building (ND)

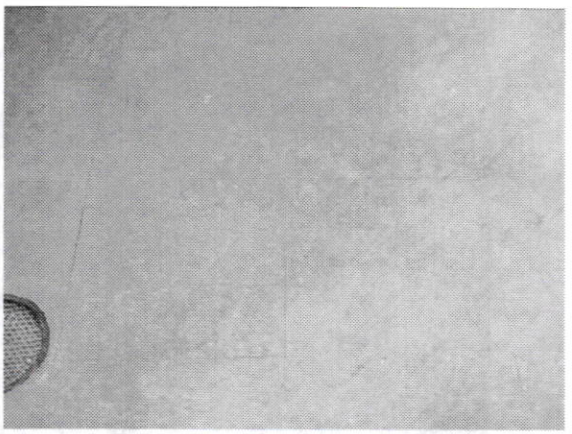
Photo #24 View of HA No. 22 – 12"x12" light brown floor tile with yellow glue located in the pharmacy building (ND)

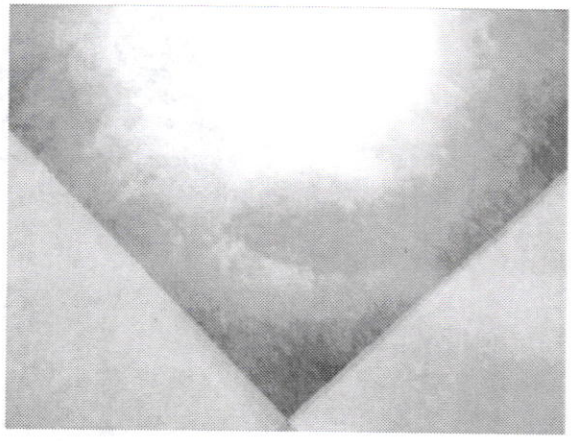
Photo #25 View of HA No. 23 – 12"x12" dark brown floor tile with yellow glue located in the pharmacy building (ND)

Photo #26 View of HA No. 24 – 12"x12" white streak floor tile with yellow glue located in the pharmacy building (ND)

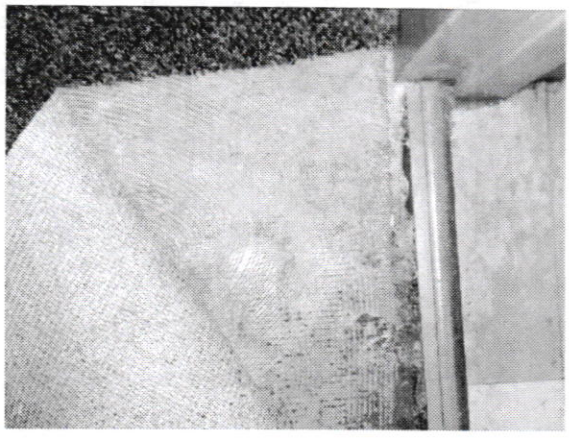
Photo #27 View of HA No. 25 – yellow carpet glue located in the pharmacy building (ND)

Photo #28 View of HA No. 26 – rubberized flooring with glue located in the IV lab of the pharmacy building (ND)

Photo #29 View of HA No. 27 – flooring from the walkway to the pharmacy building (ND)

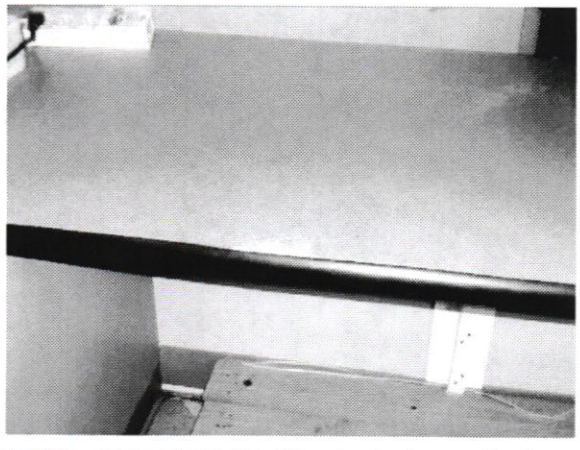
Photo #30 View of HA No. 28 – laminate counter tops with adhesive located in the pharmacy building (ND)

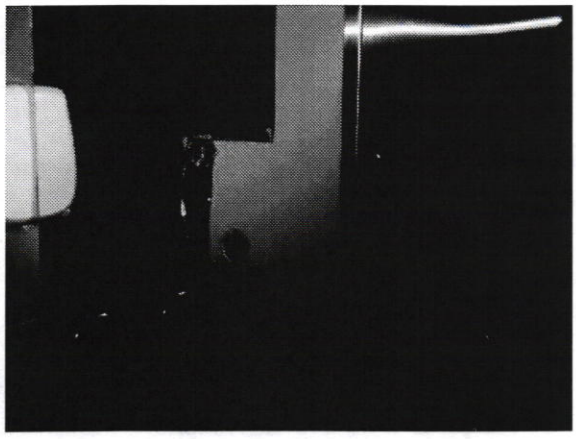
Photo #31 View of HA No. 29 – black mirror mastic behind restroom mirrors in the pharmacy building (10% C / 15% C – point count)

Terracon recommends that the identified non-friable ACM, as outlined above, be removed and disposed of by a State of Louisiana licensed asbestos abatement contractor prior to renovation activities, in accordance with a project design prepared by a State of Louisiana accredited project designer. Licensed asbestos abatement contractors should be contacted to obtain competitive bids for removal of the identified ACM. Quantities are estimates only and must be verified by the abatement contractor.

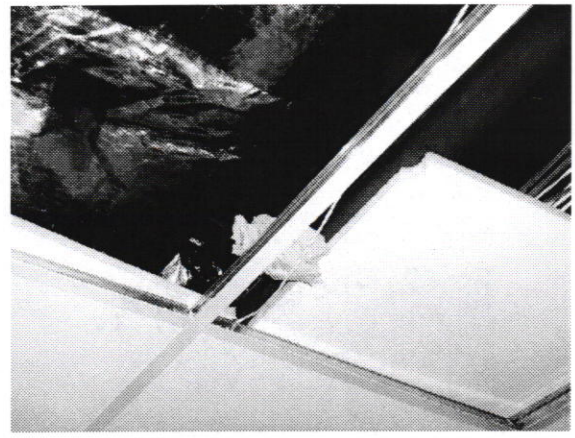
Photo #32 View of HA No. 30 – HVAC duct insulation located above the ceiling deck in the pharmacy building (ND)

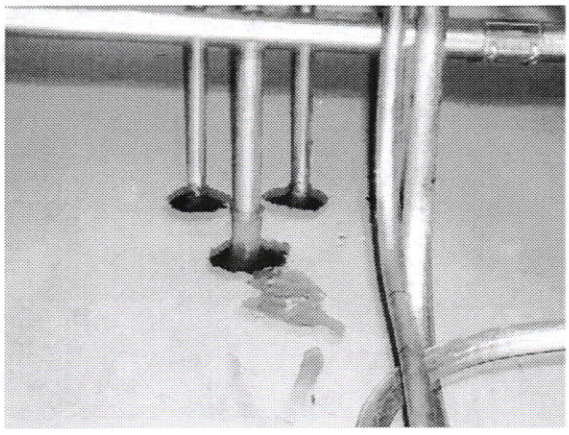
Photo #33 View of HA No. 31 – fire stop caulk located above the ceiling deck in the pharmacy building (ND)

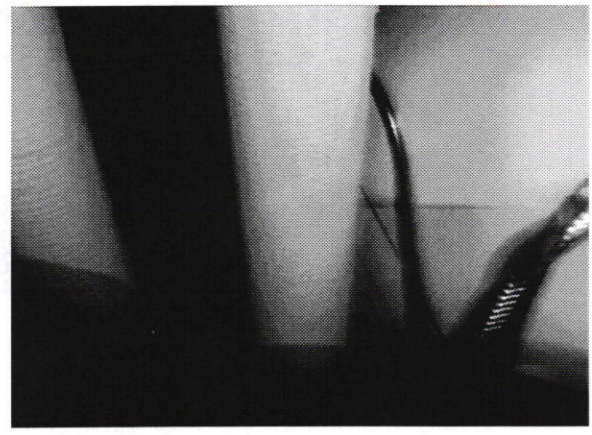
Photo #34 View of HA No. 32 – pipe insulation wrap located on pipes above the ceiling deck in the pharmacy building (ND)

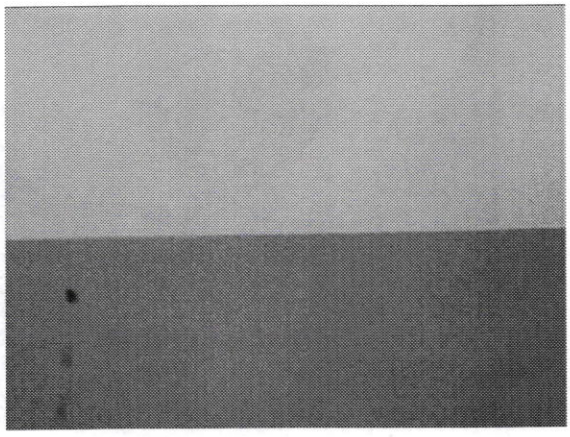
Photo #35 View of HA No. 33 – drywall ceiling with associated joint compound located in the pharmacy building (ND)

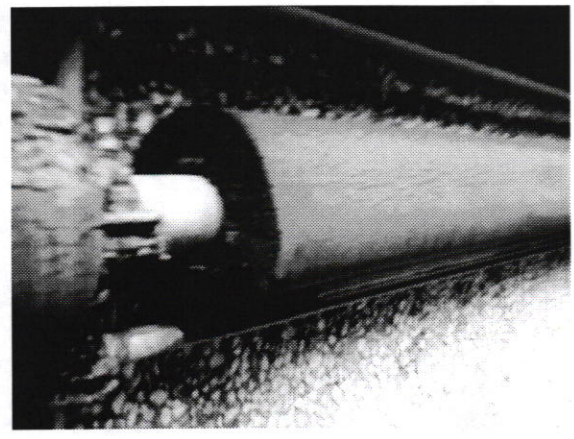
Photo #36 View of HA No. 34 – exterior pipe insulation on HVAC unit of the pharmacy building (ND)

Photo #37 View of HA No. 35 – vent flashing on the roof of the pharmacy building (ND)

Photo #38 View of HA No. 36 – pitch tar roof located on the walkway leading to the pharmacy building (ND)

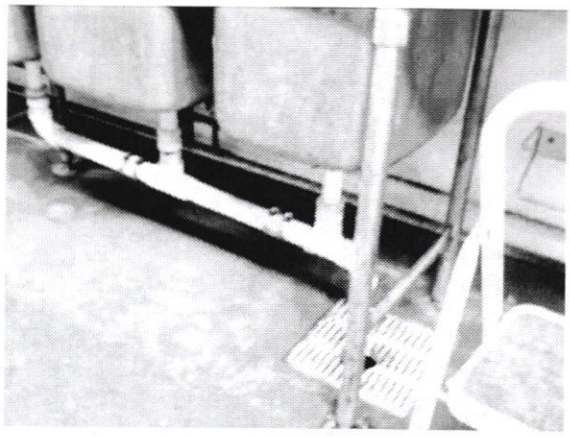
Photo #39 View of HA No. 01 – rubber floor glue located in the kitchen extension of the pharmacy building (ND)

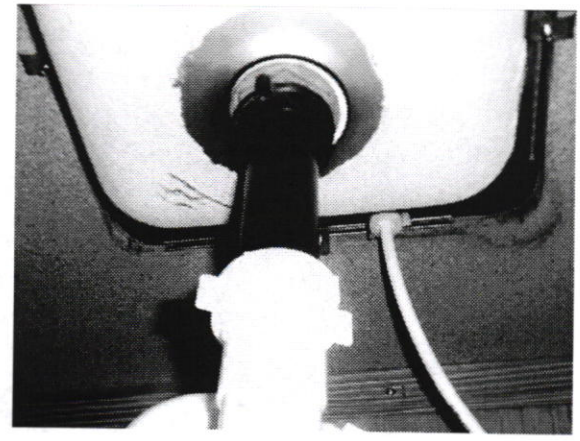
Photo #42 View of HA No. 04 – Sink undercoating in the kitchen extension of the pharmacy building (ND)

Photo #43 View of HA No. 05 – 12"x12" grey floor tile with yellow glue located in the kitchen extension of the pharmacy building (ND)

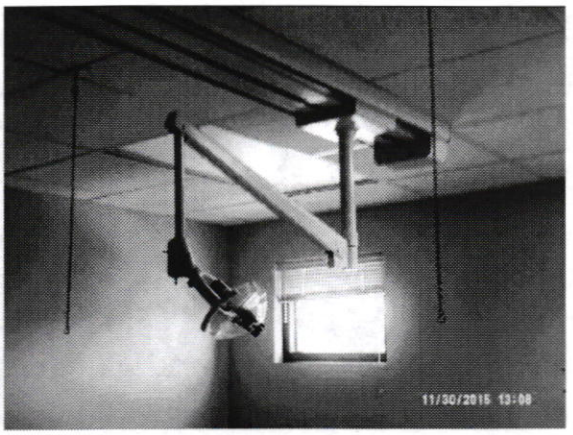
Photo #47 View of surgical lights which may contain mercury in the dental clinic

Terracon recommends the materials identified in Table 1 above be handled properly and disposed of accordingly in a facility that treats, disposes of or recycles universal waste.

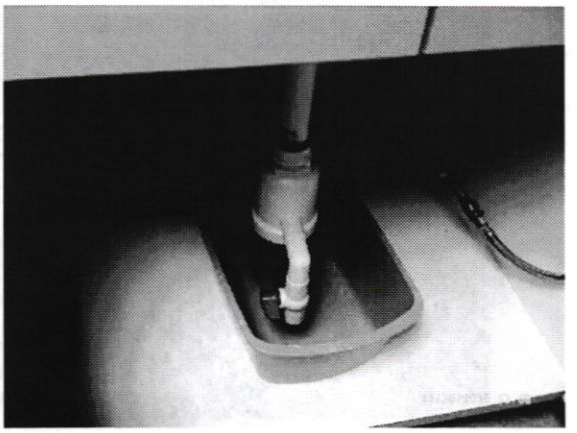
Photo #48 View of sink traps in the dental clinic laboratory area

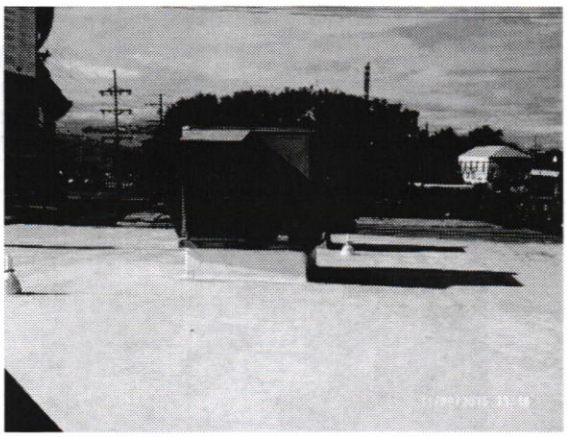
Photo #49 View of HVAC with R-410A refrigerant on top of dental clinic roof

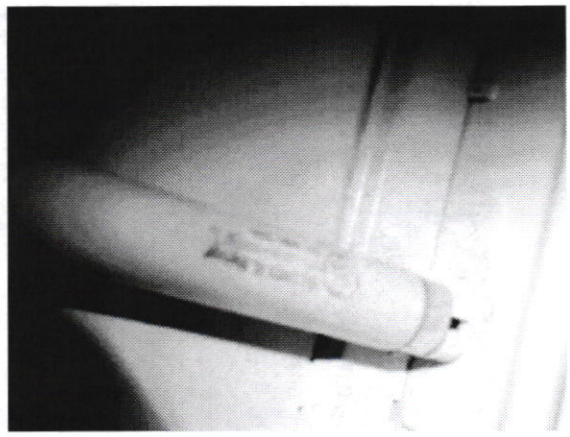
Photo #50 View of an example of Mercury containing fluorescent light bulbs in both the dental and pharmacy building

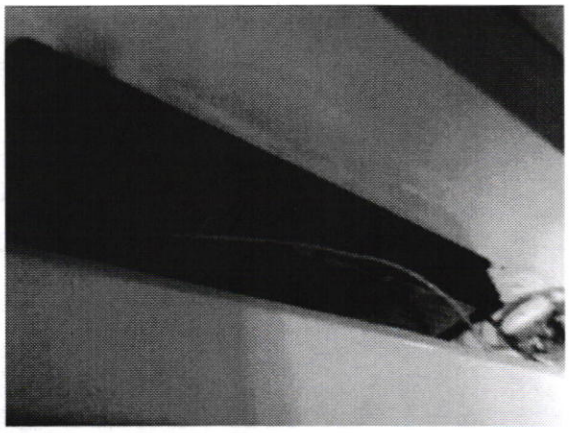
Photo #51 View of PCB containing fluorescent light ballast in both the dental and pharmacy building

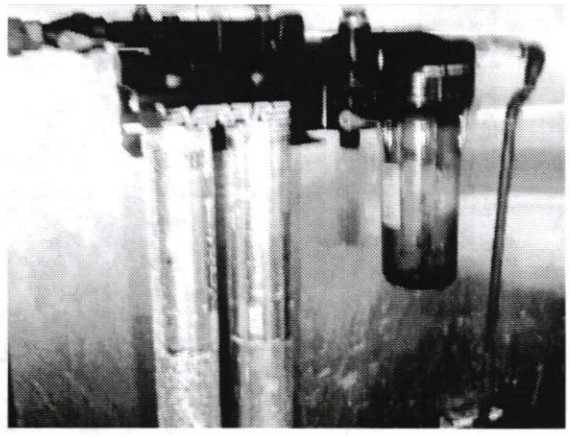
Photo #54 View of sink traps in the kitchen extension of the pharmacy building

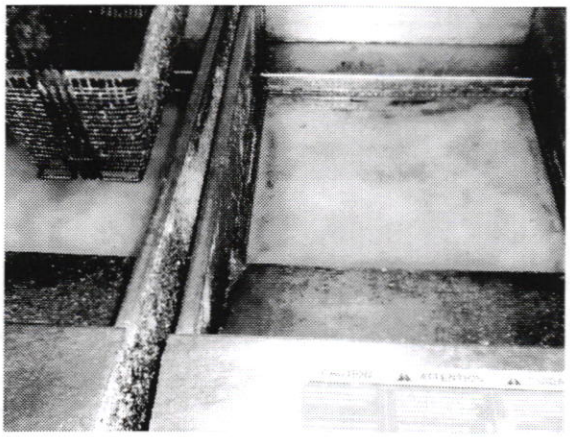
Photo #55 View of grease in fryers in the kitchen extension of the pharmacy building

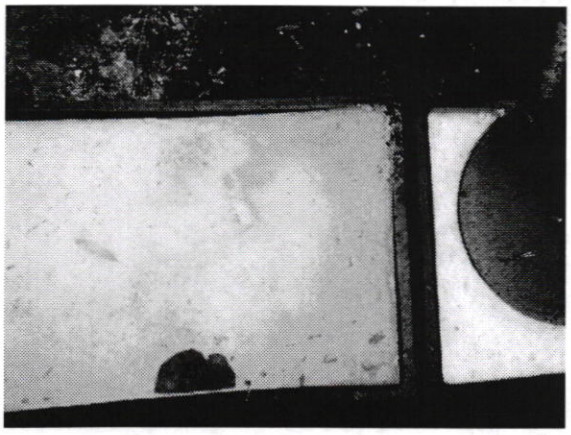
Photo #57 View of grease storage dumpster outside the kitchen extension of the pharmacy building

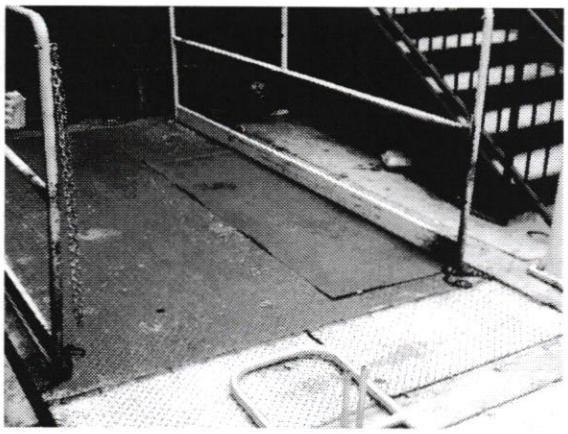
Photo #58 View of hydraulic lift located outside the kitchen extension of the pharmacy building

Photo #59 View of refrigerant containing motors for walk in freezer for kitchen extension of the pharmacy building

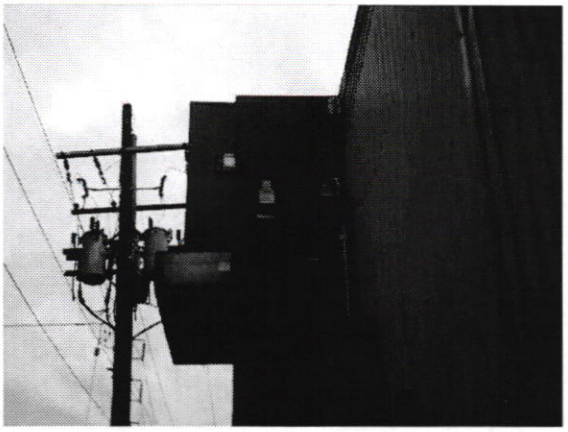
Photo #60 View of refrigerant containing HVAC unit for kitchen extension of pharmacy building
