**Addendum No.:** 1

**Bid#:** 24-52-2

**Project Name:** Structure Demolition and Slab Removal

St. Tammany Buyout Program – 1113 Schech Dr. – Lead Based Paint Inspection

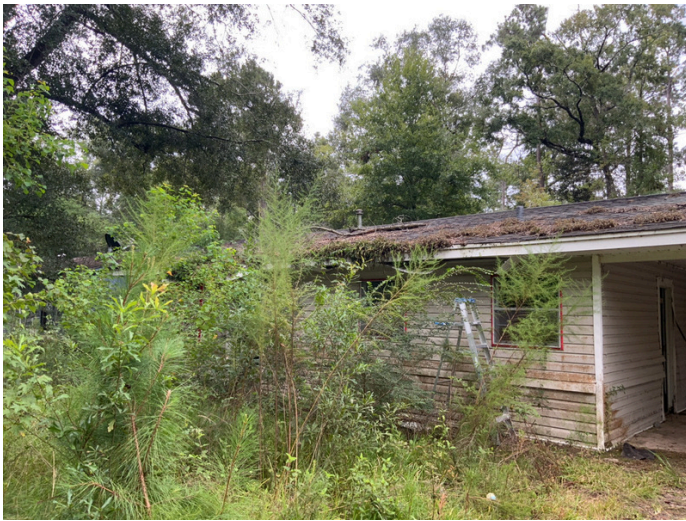
## Exterior Street View

Inspection Date:	September 4, 2024
Start Time	08:46
Owner / Resident Name:	St. Tammany Parish
Site Address:	1113 Schech Dr Covington LA 70433 US
Prepared for:	St. Tammany Parish Buyout Program
Client Contact:	
Client Address:	21490 Koop Dr. Mandeville LA 70471 US
Client Phone:	(985) 898-2591
Prepared by:	ELOS
Firm Certification #	LBP-F208860-2
Firm Address:	607 W. Morris Ave., Hammond, LA 70403
Firm Phone:	(985) 662-5501
Inspector Name:	Eric Poche
Inspector License #	J1208652 and JR208652
Report Summary	Lead painted surfaces were detected on the exterior portion of the building. The listed areas were identified as lead and deteriorating: Exterior Walls A, B, C, and D; Exterior Dwelling Entrance Casing Wall D; Exterior Laundry Room Equivalent Entrance Casing Wall A

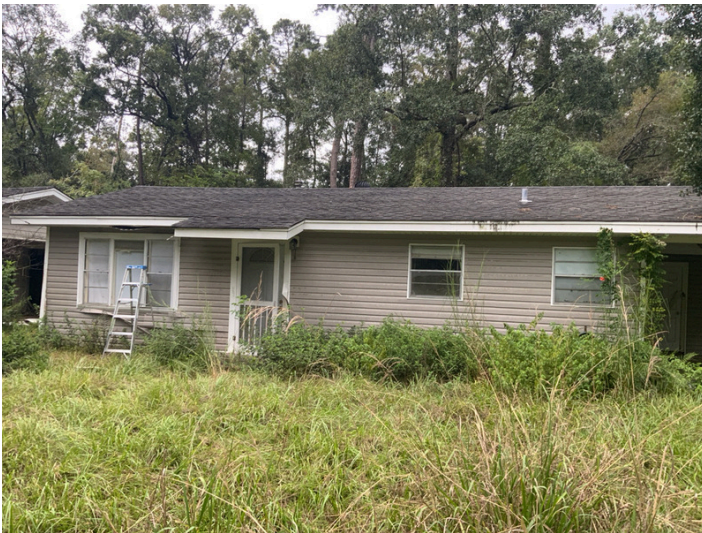
**Exterior Photo**

<b>Site Name</b>	
<b>Site Address</b>	1115 Schech Dr Covington LA 70433 US
<b>Inspection Start Date</b>	September 4, 2024
<b>Inspection Conducted By:</b>	Eric Poche
<b>Inspector Certification Number</b>	DI2108652
<b>Purpose of Survey</b>	Pre-Demolition
<b>Summary of Results</b>	Brown and black mastic was identified as containing asbestos and all like materials are considered positive.

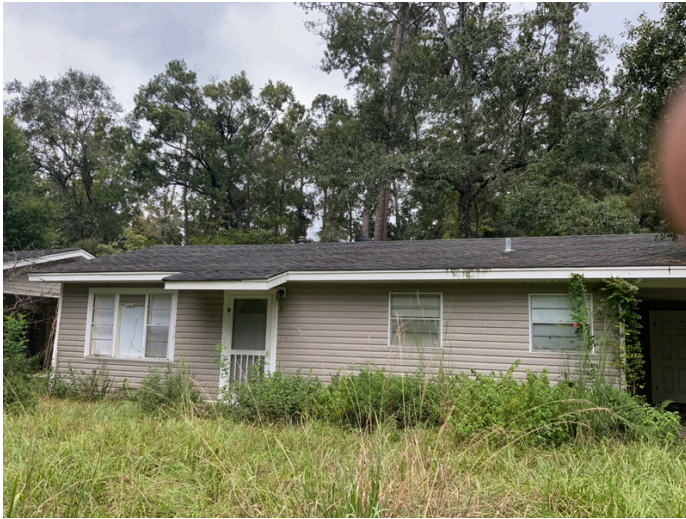
## Exterior Street View

<b>Inspection Date:</b>	September 4, 2024
<b>Start Time</b>	11:50
<b>Owner / Resident Name:</b>	St. Tammany Parish
<b>Site Address:</b>	1115 Schech Dr Covington LA 70433 US
<b>Prepared for:</b>	St. Tammany Parish Buyout Program
<b>Client Contact:</b>	
<b>Client Address:</b>	21490 Koop Dr. Mandeville LA 70471 US
<b>Client Phone:</b>	(985) 898-2591
<b>Prepared by:</b>	ELOS
<b>Firm Certification #</b>	LBP-F208860-2
<b>Firm Address:</b>	607 W. Morris Ave., Hammond, LA 70403
<b>Firm Phone:</b>	(985) 662-5501
<b>Inspector Name:</b>	Eric Poche
<b>Inspector License #</b>	J1208652 and JR208652
<b>Report Summary</b>	Lead painted surfaces were detected on the exterior portions of the building. The listed areas were identified to contain lead: Exterior Walls A, B, C, D; Exterior Carport Ceiling; Exterior Roof Soffit Wall A
