Attachment B – Scope of Work

RFx No.: 3000023440

Title: *Rebid*Mand.SiteVisit*Vessel Repair-LDWF

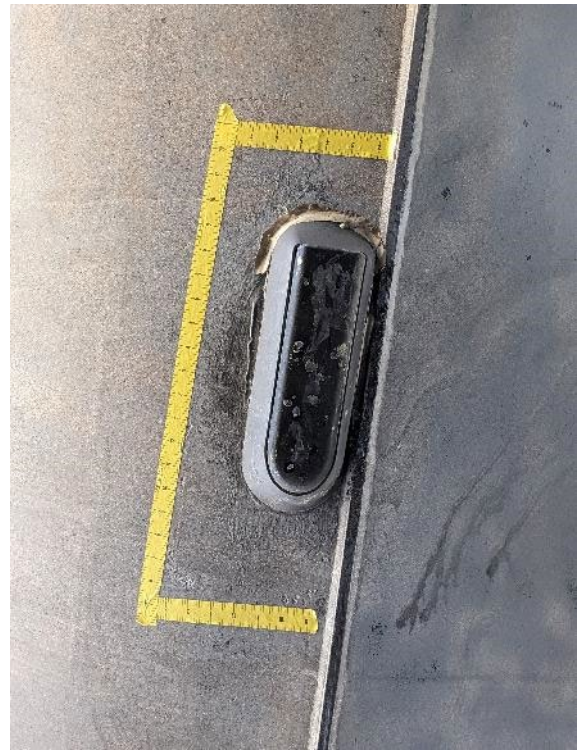
- Remove the depth transducer from the port hull mid-ship area. Crop out hull plating surrounding the penetration for the transducer approximately 2-ft. x 1-ft. area is marked in photographs. Re-plate as original. Reinstall transducer and test operation.
